LOW COST EROSION CONTROL

CASE STUDIES IN THE KYEAMBA VALLEY

By Cam Wilson *for* Kyeamba Valley Landcare Group

This booklet was produced through the project
“Slow the Flow: Erosion Control in the Kyeamba Valley”,
funded by the NSW Environmental Trust

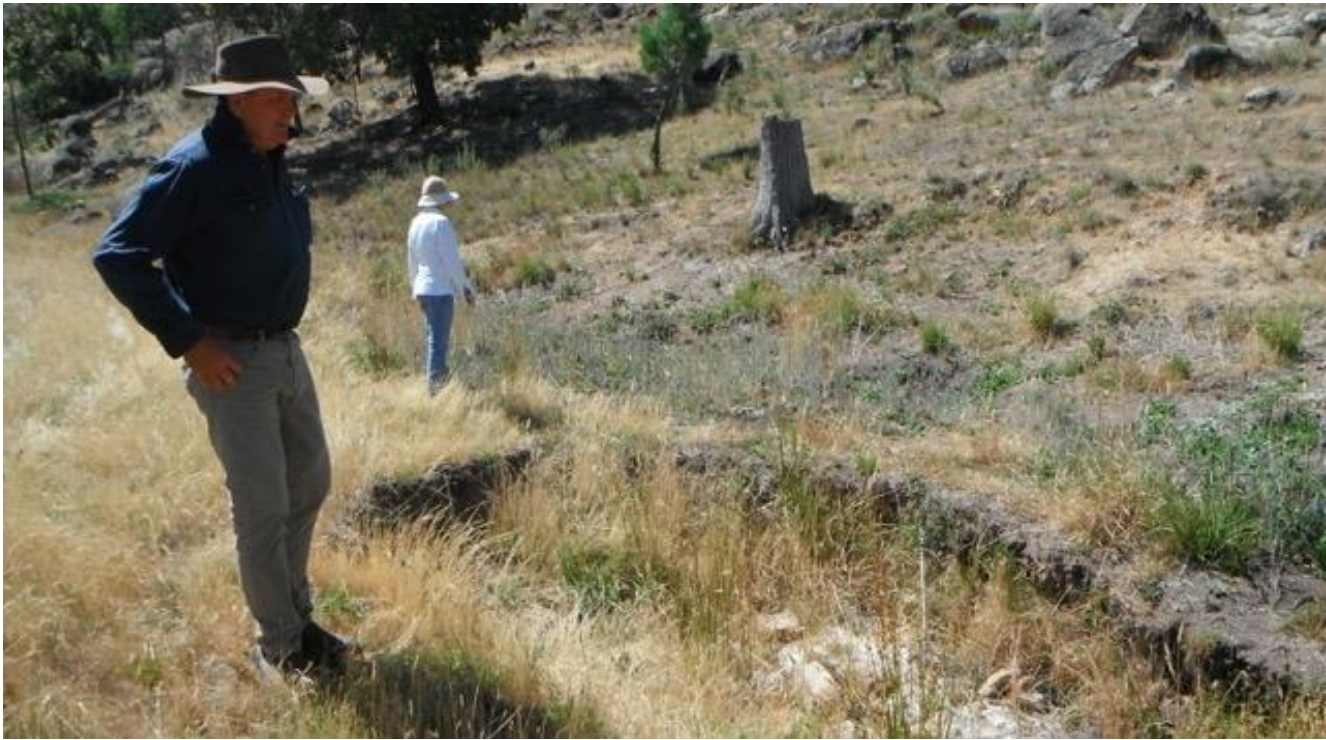
A large blackberry bush was present within the flow line during a major flow event. This deflected the flow sideways, and caused it to re-enter down a steep section, initiating a headcut (as shown in the photo below) that migrated around 10 metres upstream.

Property:	'Silver Springs', Big Springs
Erosion:	Headcut formation & migration
Causes:	Flow obstruction & diversion
Catchment:	50 ha
Proposal:	Rock Rundown

If such a headcut was threatening a valuable natural or farm asset, then armouring with a Rock Rundown would be the recommended strategy. With a catchment area of nearly 50

hectares, an average rock diameter of 300 mm would be recommended, with rocks placed carefully and in-filled with gravel and soil. If the material was just to be dumped in place, a larger rock diameter would be recommended. Geotextile fabric would also be required, with Bidim A24 standard the minimum grade.

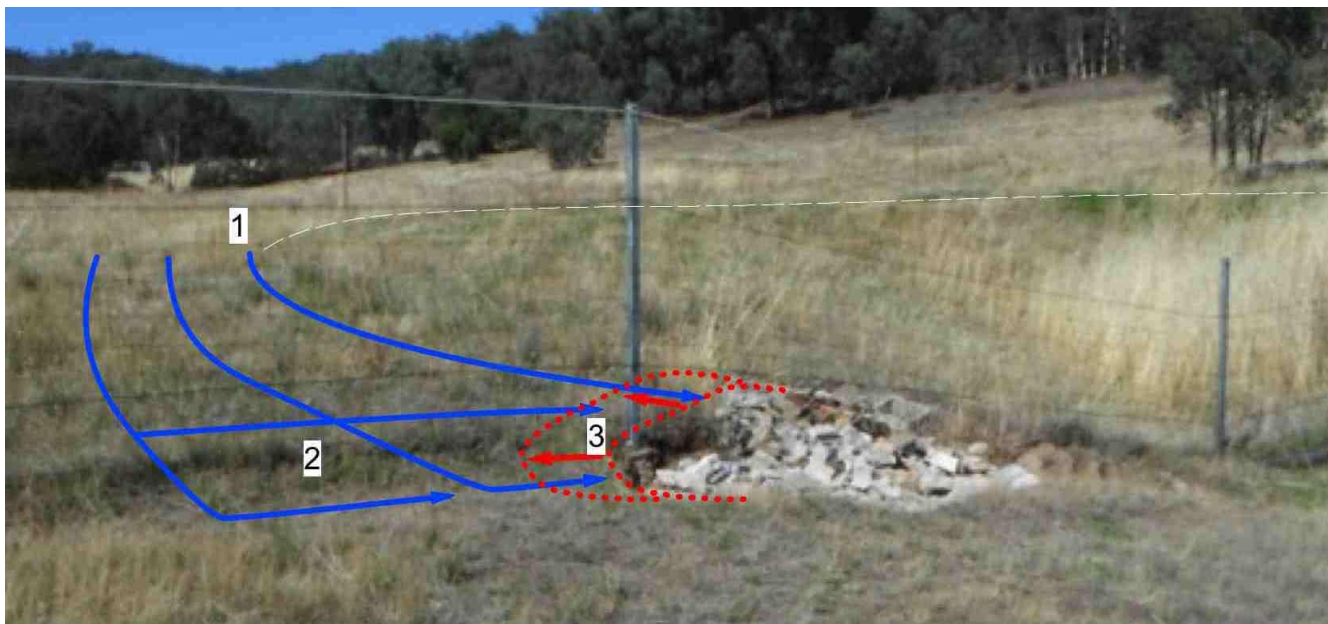
During a large runoff event, flow along the spillway of the dam, shown at (1) in the photo below, was diverted and concentrated along both sides of a fenceline (2). This was caused by a combination of stock tracks, increased vegetation and organic-debris accumulation. The concentrated flow, in combination with the steep return slope, the sudden change in soil level on the downhill side of the fence and the minimal topsoil and vegetation along the fenceline due to tracking, resulted in a small headcut (3) commencing near the toe of the slope and migrating to its current location.

Rubble was added to the channel by the landholder. While this helped to slow the flow down within the eroded channel, the face of the headcut was still exposed and over time would still wash away and migrate uphill towards the dam, due to the highly erodible nature of the soils. This projected movement is shown by the red arrows in the photo above. Material of this size could also be transported by the peak flows that could be expected.

Any extension of the spillway should allow a minimum flow of six metres wide and 0.5 metres deep, to convey the peak flows (Lewis, 2002). The outlet should be located where a combination of good vegetation and the shallowest gradient is found. The old cut could easily be filled in at the same time.

If there is no other reason for having earthwork machinery on the site, then armouring of the headcut with a Rock Rundown would be recommended. An average diameter of 200-250 mm rock would be recommended on the upper surface.

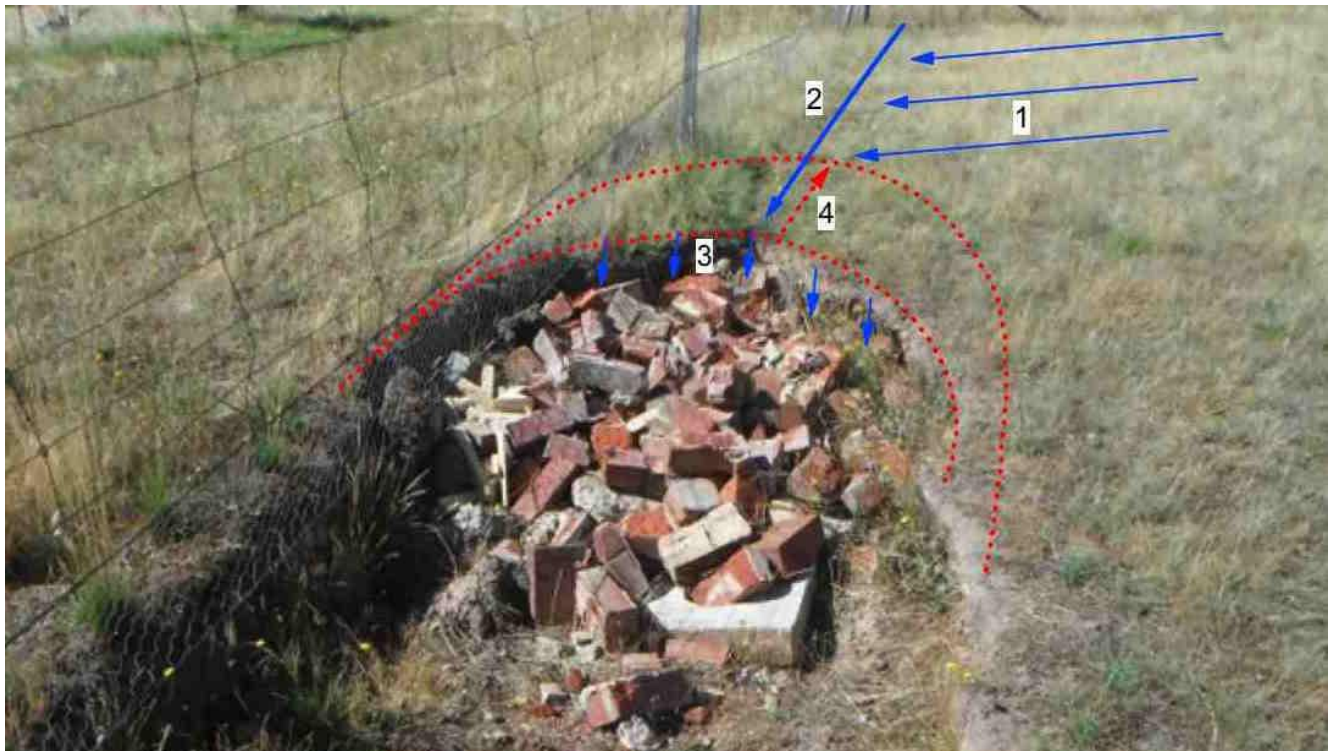
Property:	'Lanacoora', Big Springs
Erosion:	Headcut formation & migration
Causes:	Flow concentration and erodible soils
Catchment:	40 ha
Proposals:	Rock Rundown, Rock / Earth Berm

The most economical approach for halting the migration of this cut is to shape and armour the face with a Rock Rundown, with the approximate upper extent indicated by the yellow curve in the photo on the following page. With the small catchment area, the material that is in the hole will be fine for doing the job, but it would be recommended to place a layer of 2 mm geotextile fabric underneath the rock/brick material, due to the dispersive nature of the soil on the site. If the hole was to be left open, an apron of netting on the opposite side of the

If filling of the hole was desired, then a small diversion around the top of the filled hole would be recommended to minimise surface flows. This could be achieved with a rock or earth berm placed a couple of metres above the cut that tips the flow safely to the downhill side, as shown in the graphic overlay of the photo at right.

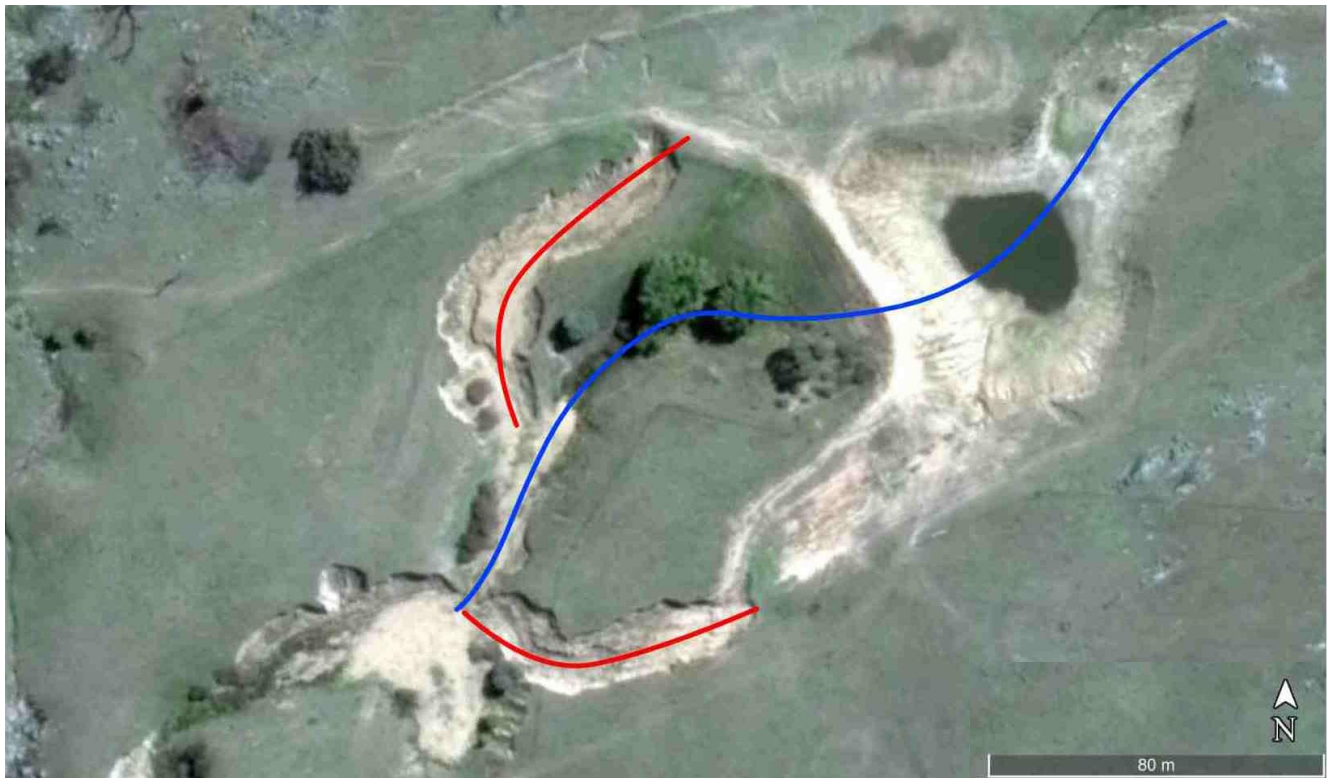
Property:	'Silver Springs', Big Springs
Erosion:	Headcut formation, channel incision, and gully erosion
Causes:	Dam impacts and erodible soils
Catchment:	100 ha
Proposal:	Rock Flume

The condition of the reaches upstream and downstream from the dam site indicates that it is likely that the channel (shown by the blue line in the photo below) was well stabilised prior to the construction of the dam. The channel had undergone a historical phase of incision, with sufficient time to go through the full set of stages of the evolution of an incised channel.

However the construction of the dam resulted in peak flows returning to the channel floor over a considerably shorter distance (shown by the red lines in the photo below) compared with the prior conditions (blue line). This included the relatively steep sidewalls of the old channel. The steeper the slope, the greater the erosive power, and in this instance the binding power of the vegetation has been insufficient in relation to the inherent erodibility of the soils, resulting in the tributary erosion process commencing.

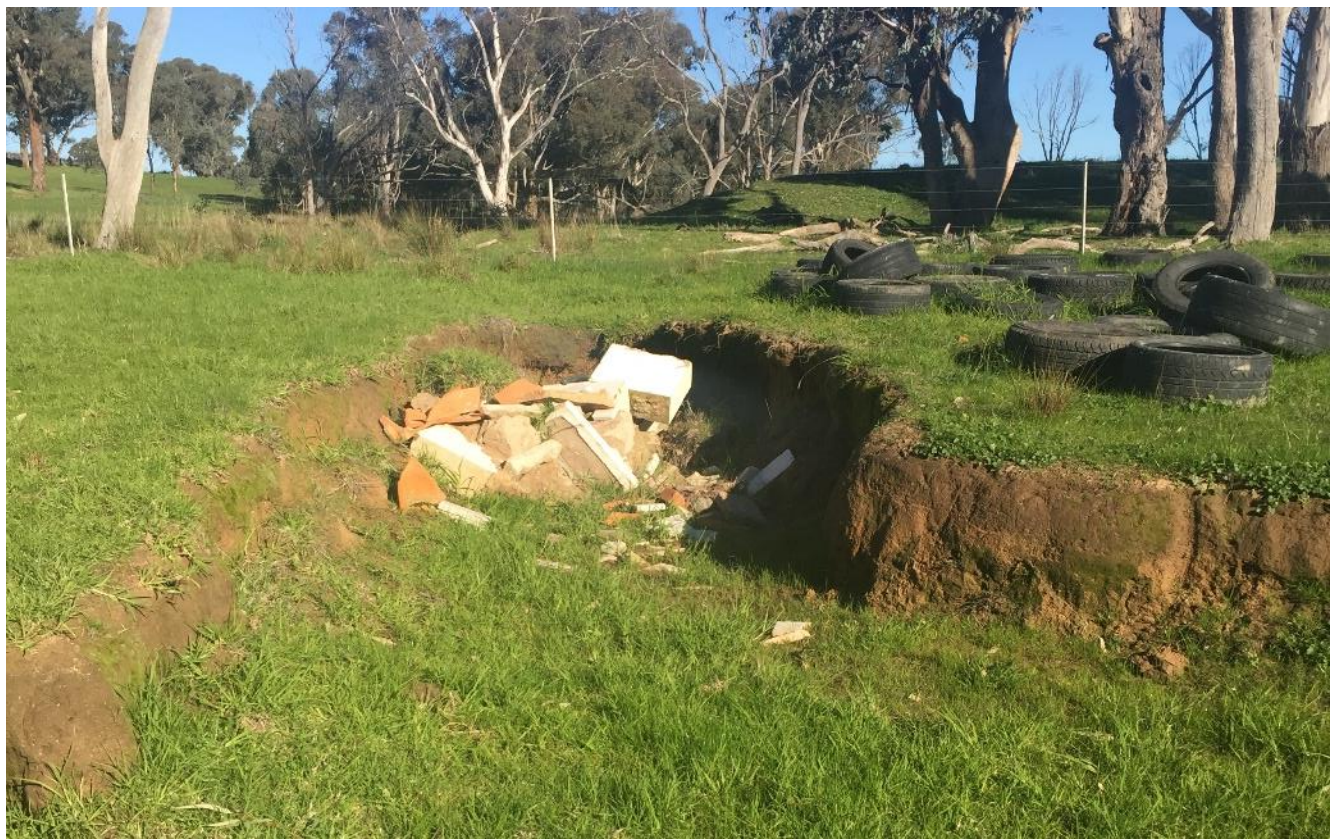
As can be seen in the below photo of the upstream view of the site, the landholder has already placed rubble against the face in an attempt to slow the erosion. However significant contact between flow and the erodible subsoil has continued, resulting in undermining and collapse of the topsoil/sod blocks and ongoing retreat.

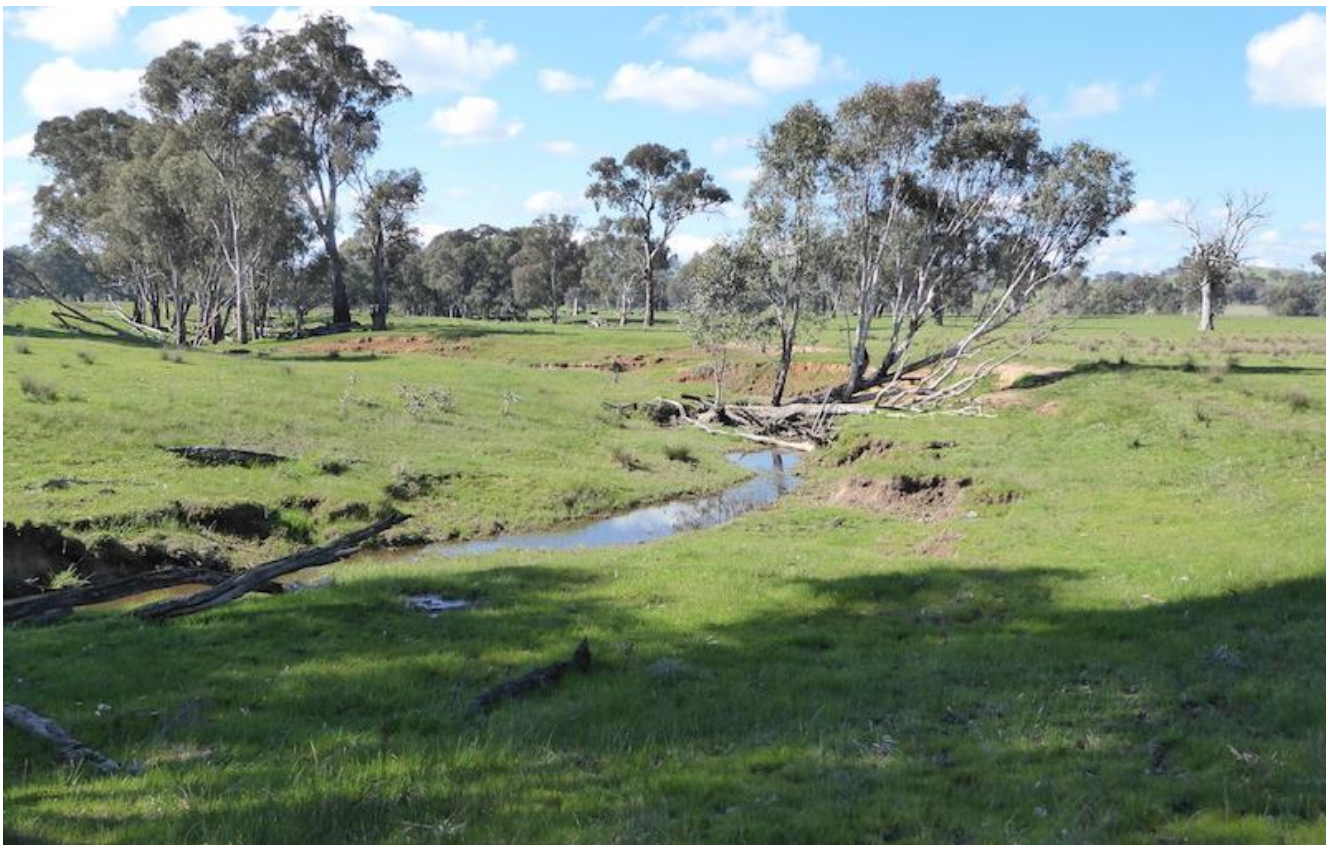
Undercutting caused by scour on the outside of the bend shown in the photo on the previous page has resulted in mass failure, with blocks of soil/sod sliding down the bank. This is a part of the ongoing widening process following a lowering of the bed. Vegetation within the channel and banks has been heavily grazed by stock, providing minimal flow resistance and preventing water loving plants from reaching their full potential

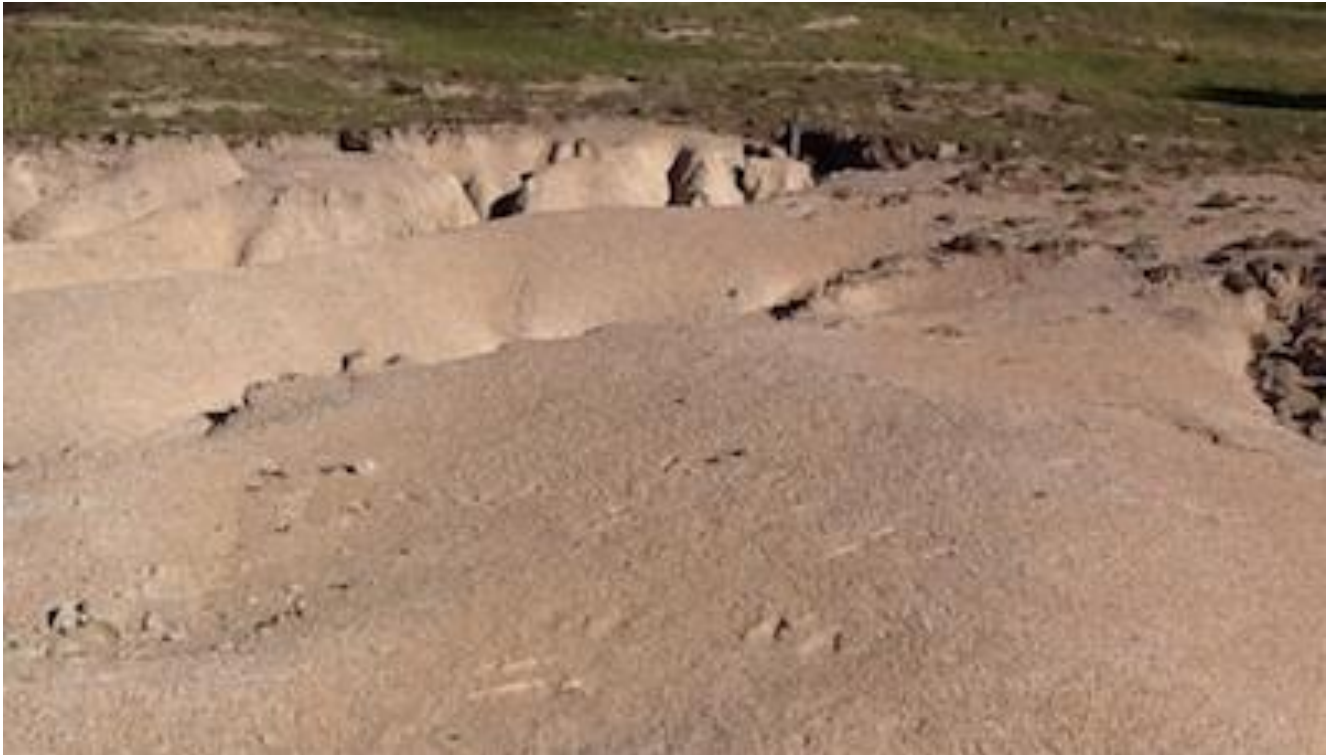
The subsoil is sodic and highly erodible, becoming very unstable and boggy when wet, and hard-setting when dry. Once exposed, these soils are prone to capping and the ongoing presence of a scald, as can be seen in the photo below. This is caused by inherently unstable clay particles being dislodged by direct rainfall impact, and then clogging the soil pores at the surface. Once capping occurs, infiltration is restricted, and the conditions become inhospitable for seed germination and vegetation establishment.

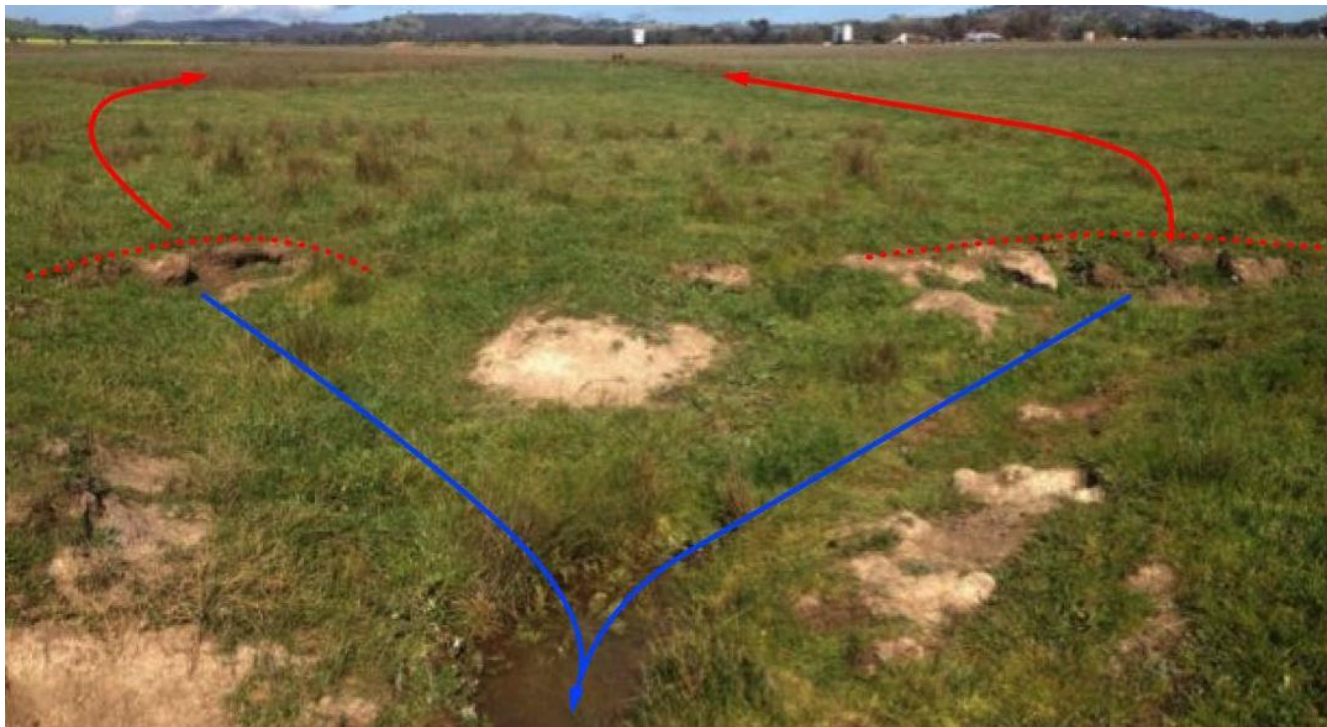
The photo at right of the downstream view shows the erosion pathway. The channel itself is well stabilised and of no concern.
