LOW COST EROSION CONTROL

CASE STUDIES IN THE KYEAMBA VALLEY

By Cam Wilson *for* Kyeamba Valley Landcare Group

This booklet was produced through the project
“Slow the Flow: Erosion Control in the Kyeamba Valley”,
funded by the NSW Environmental Trust

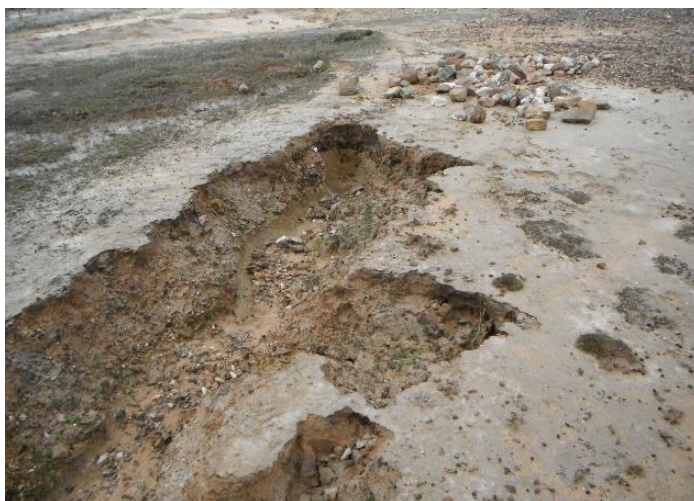
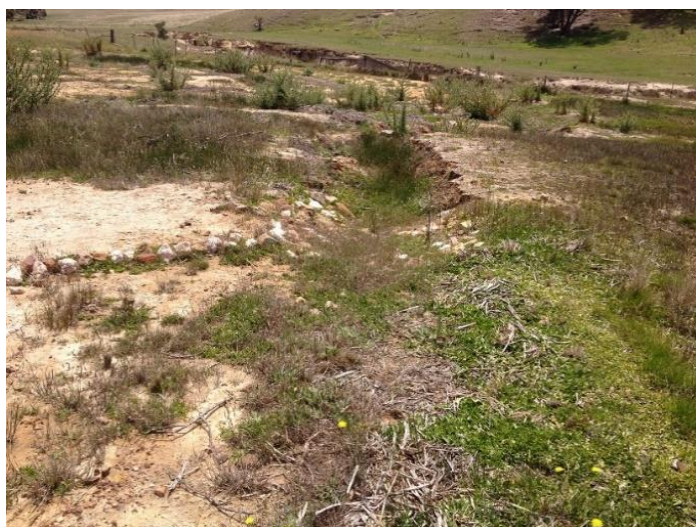
The photos at right show an active headcut, extending a small gully uphill (top). The image below right shows a downstream view of the same headcut following the construction of a Rock Rundown (mid-frame), and addition of brush material and hay to the floor of the rill.

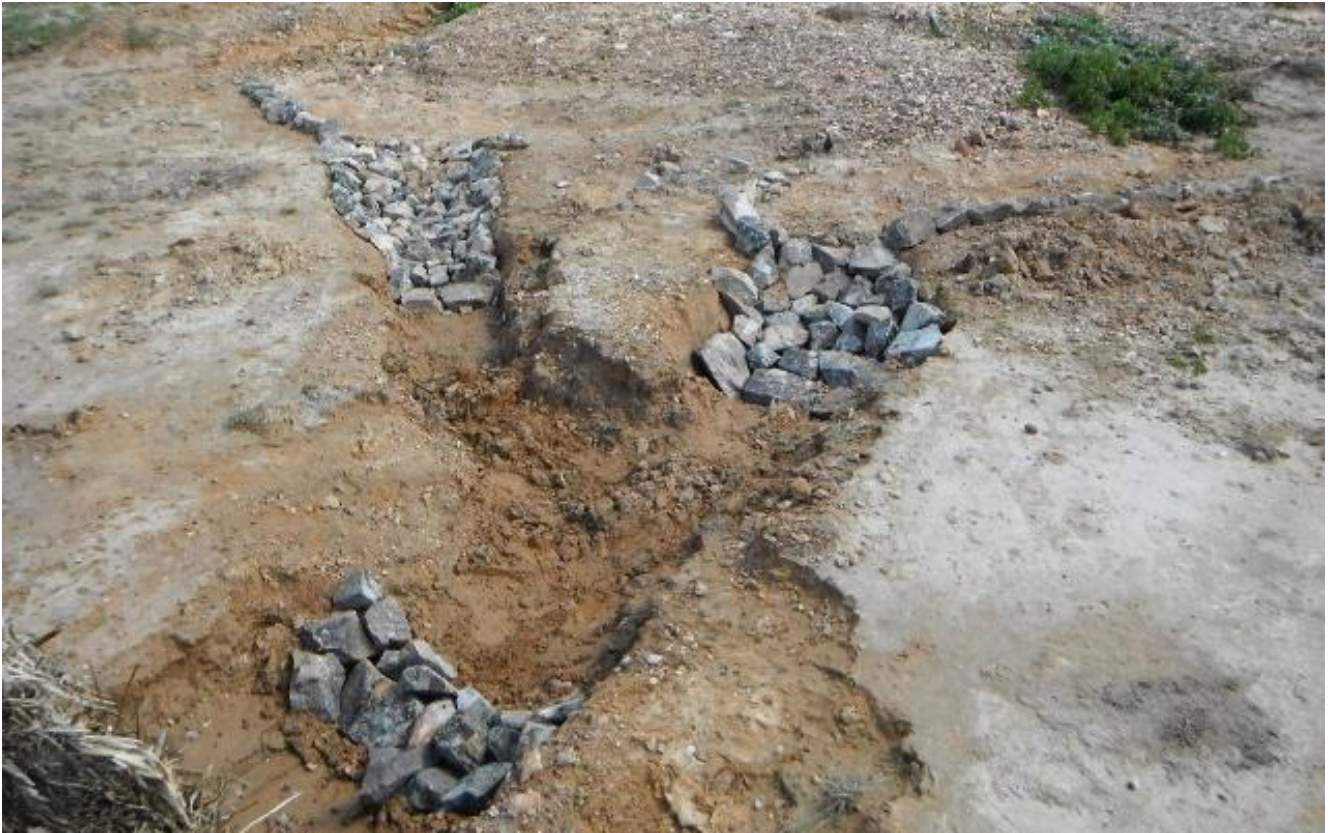
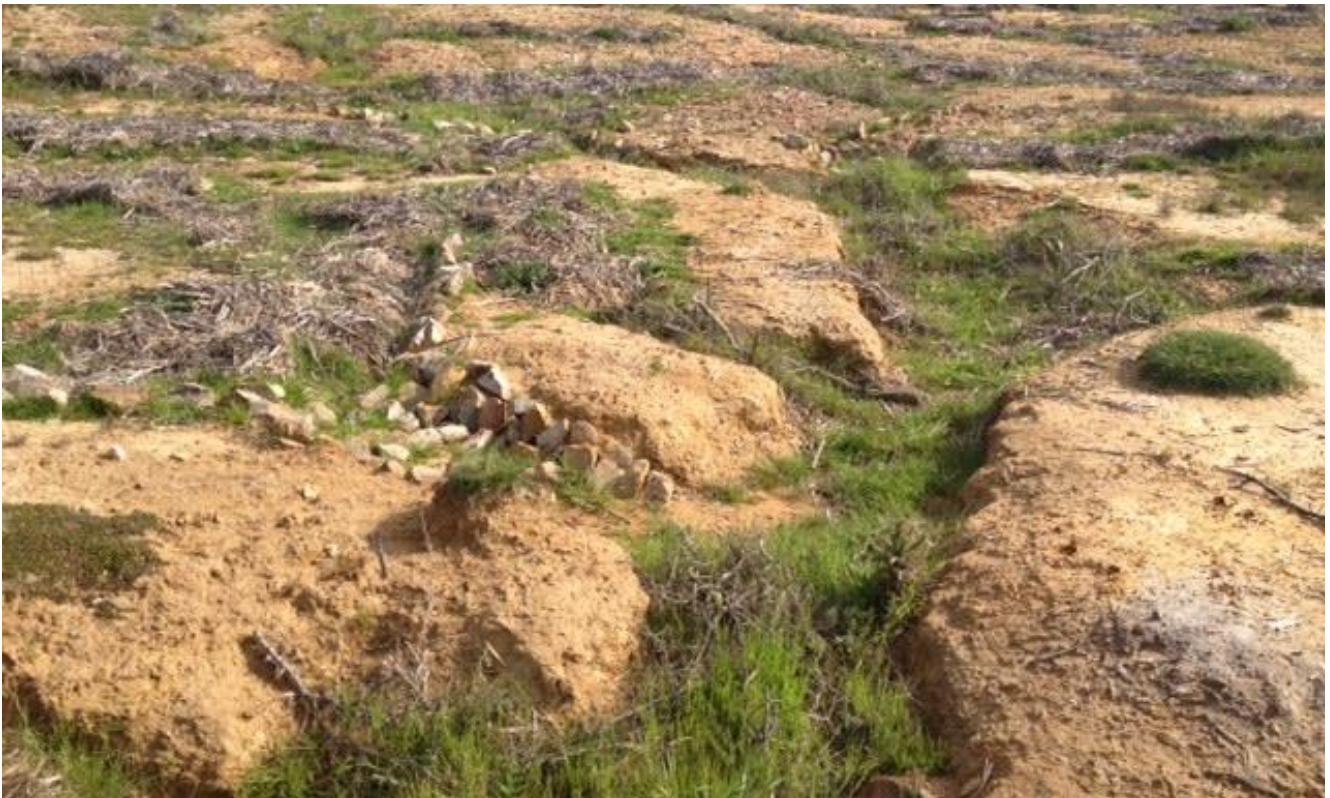
In the photos below, minor headcuts have been armoured with Rock Rundowns, with a One Rock Dam for grade control below and Brush Mattressing above. Hay was later added along the contour at intervals of approximately three metres and scattered on the floor of the rills. The image at the bottom shows the same site ten months after the works were completed.

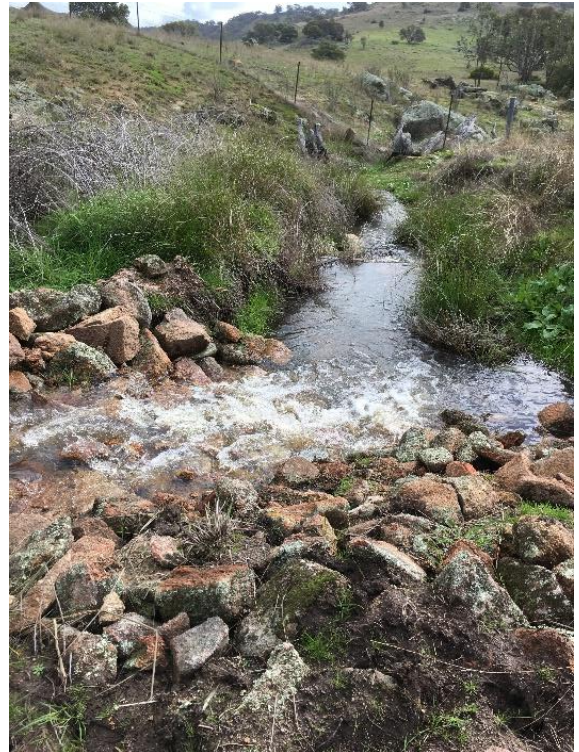
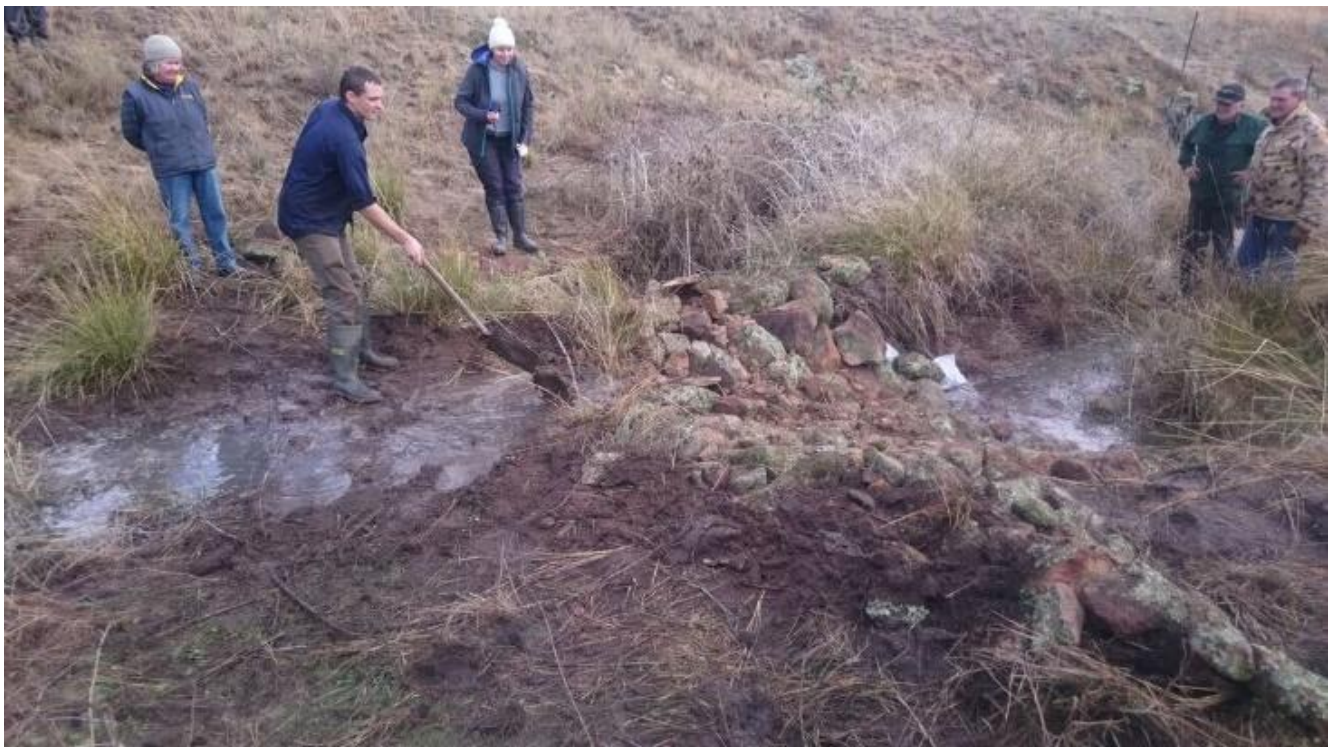
A large blackberry bush was present within the flow line during a major flow event. This deflected the flow sideways, and caused it to re-enter down a steep section, initiating a headcut (as shown in the photo below) that migrated around 10 metres upstream.

Property:	'Silver Springs', Big Springs
Erosion:	Headcut formation & migration
Causes:	Flow obstruction & diversion
Catchment:	50 ha
Proposal:	Rock Rundown

The landholders tapered the headwall using pick and shovel, then covered it with geofabric before armouring with a Rock Rundown. Rock was collected locally (on-property) with a front end loader. Gypsum was also added. The streamline was realigned to prevent the overflow from creating another channel in the same manner. The photo below shows the landholders undertaking the works, with the assistance of several other Landcare members as part of a working bee. The photo at right shows the completed works.

The landholders have found the completed works to be very successful, and believe the technique would be suitable for other sites on their property.

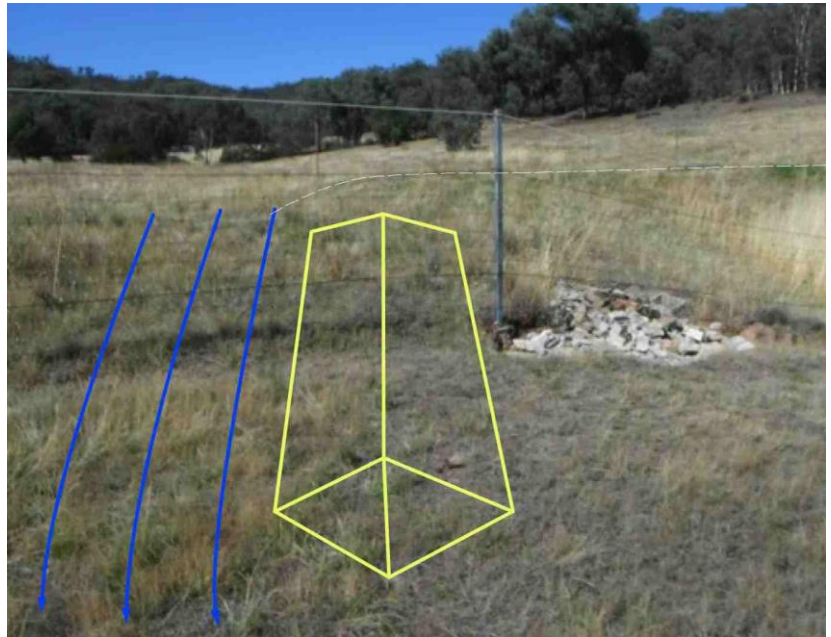
Property:	'Lanacoora', Big Springs
Erosion:	Headcut formation & migration
Causes:	Flow concentration & diversion, erodible soils and dam impacts
Catchment:	40 ha
Proposals:	Rock Rundown, Dam Spillway extension

During a large runoff event, flow along the spillway of the dam, shown at (1) in the photo below, was diverted and concentrated along both sides of a fenceline (2). This was caused by a combination of stock tracks, increased vegetation and organic-debris accumulation. The concentrated flow, in combination with the steep return slope, the sudden change in soil level on the downhill side of the fence and the minimal topsoil and vegetation along the fenceline due to tracking, resulted in a small headcut (3) commencing near the toe of the slope and migrating to its current location.

Any extension of the spillway should allow a minimum flow of six metres wide and 0.5 metres deep, to convey the peak flows (Lewis, 2002). The outlet should be located where a combination of good vegetation and the shallowest gradient is found. The old cut could easily be filled in at the same time.

If there is no other reason for having earthwork machinery on the site, then armouring of the headcut with a Rock Rundown would be recommended. An average diameter of 200-250 mm rock would be recommended on the upper surface.

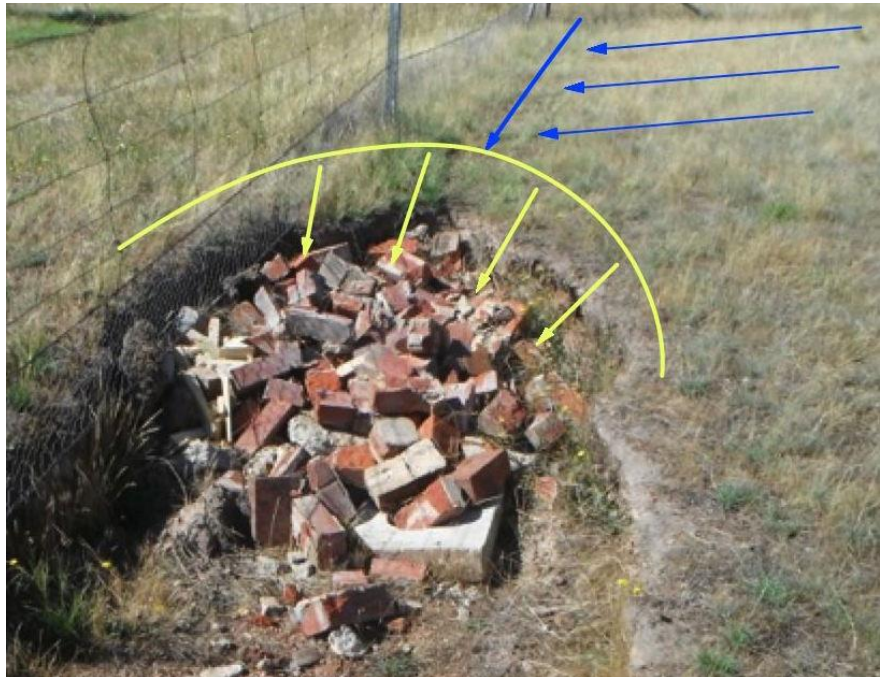
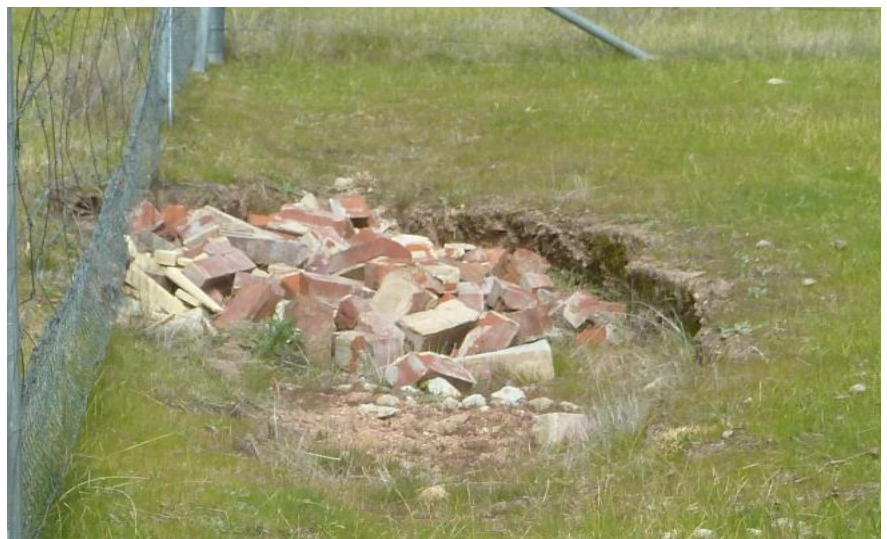
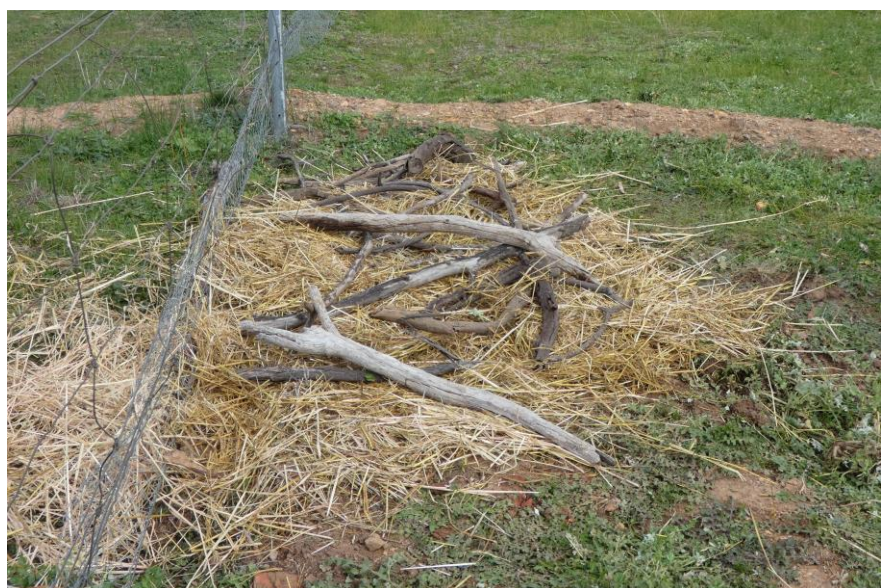
The landholders filled the holes with rubble, and covered this with soil and hay, as can be clearly seen in the photos at right of the site during (middle) and after construction (bottom). As described under Site 2, a low 4.5 metre long diversion bank was also constructed at the head of the site, providing further protection, while a scattering of timber has helped to deter stock from making another track along the fenceline.

The most economical approach for halting the migration of this cut is to shape and armour the face with a Rock Rundown, with the approximate upper extent indicated by the yellow curve in the photo on the following page. With the small catchment area, the material that is in the hole will be fine for doing the job, but it would be recommended to place a layer of 2 mm geotextile fabric underneath the rock/brick material, due to the dispersive nature of the soil on the site. If the hole was to be left open, an apron of netting on the opposite side of the

If filling of the hole was desired, then a small diversion around the top of the filled hole would be recommended to minimise surface flows. This could be achieved with a rock or earth berm placed a couple of metres above the cut that tips the flow safely to the downhill side, as shown in the graphic overlay of the photo at right.

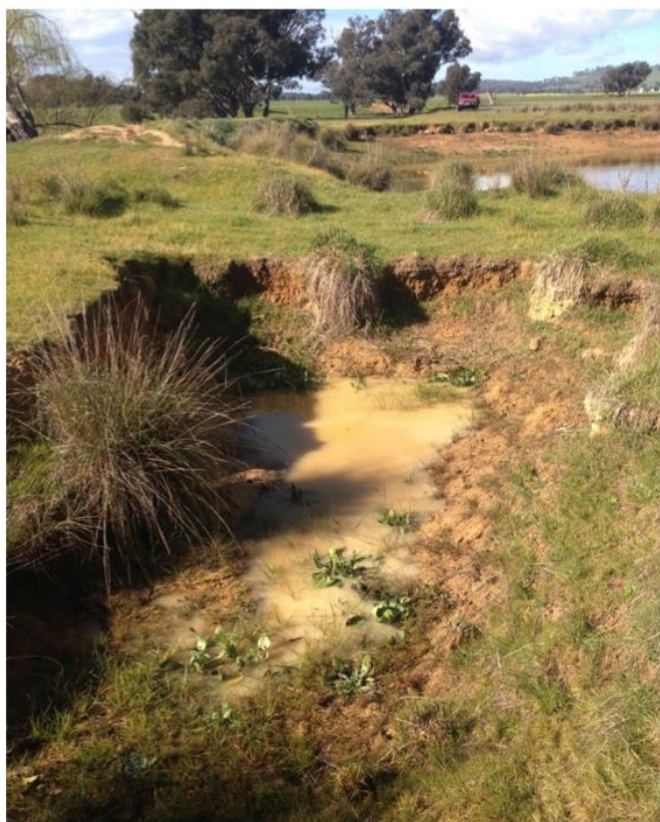
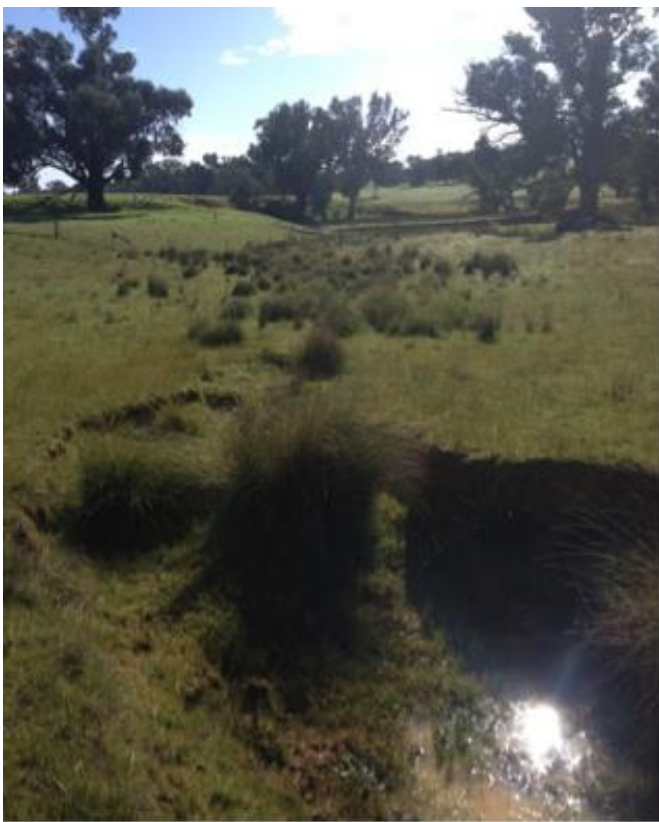
Site 4: Headcut formed by concentrated flow from a spillway

This site is situated on a second order watercourse. Concentrated flow from the spillway of the dam formed a headcut during a major rain event. The headcut is five metres wide and one metre tall and, while the gully is quite short, it threatens to compromise the dam. The photos below show the upstream (left) and downstream (right) views of the headcut.

Property:	'Aryshire Park', Big Springs
Erosion:	Headcut formation
Causes:	Flow concentration and dam impacts
Catchment:	160 ha
Proposal:	Dam spillway extension

The floor of the valley is quite intact, and vegetated with a good cover of *Carex appressa* (Tall Sedge), as can be seen in the downstream view in the photo above, and also by the green hatching in the aerial photo on the following page. This feature, in combination with the gentle slope on the left bank, offers a safe re-entry zone.

Earthworks are therefore recommended as the most cost effective solution on this site, diverting the flow in a 1 in 400 channel to a level sill spillway. The earthworks should be

designed to divert the flow from its current path, shown by the red line in the aerial photo, to the path shown by the blue lines, returning the flow to the well-vegetated valley floor indicated by the green hatching.

The catchment area has been estimated at 160 hectares from aerial imagery. This would result in peak flows of 5.4 cubic metres per second for an average recurrence interval of 50 years which, according to the table in Appendix Two, requires an outlet width of approximately eight metres for the low gradient setting.

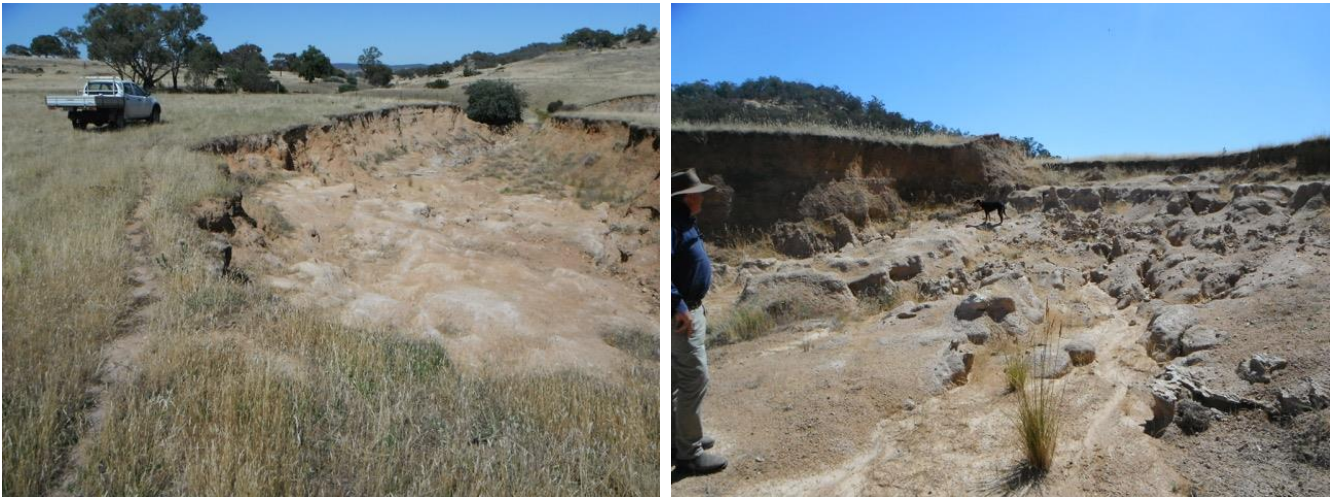
However the construction of the dam resulted in peak flows returning to the channel floor over a considerably shorter distance (shown by the red lines in the photo below) compared with the prior conditions (blue line). This included the relatively steep sidewalls of the old channel. The steeper the slope, the greater the erosive power, and in this instance the binding power of the vegetation has been insufficient in relation to the inherent erodibility of the soils, resulting in the tributary erosion process commencing.

The result is large-scale erosion, as shown in the photos below, of the view downstream of the southern headcut (left), and upstream towards the southern headcut (right).

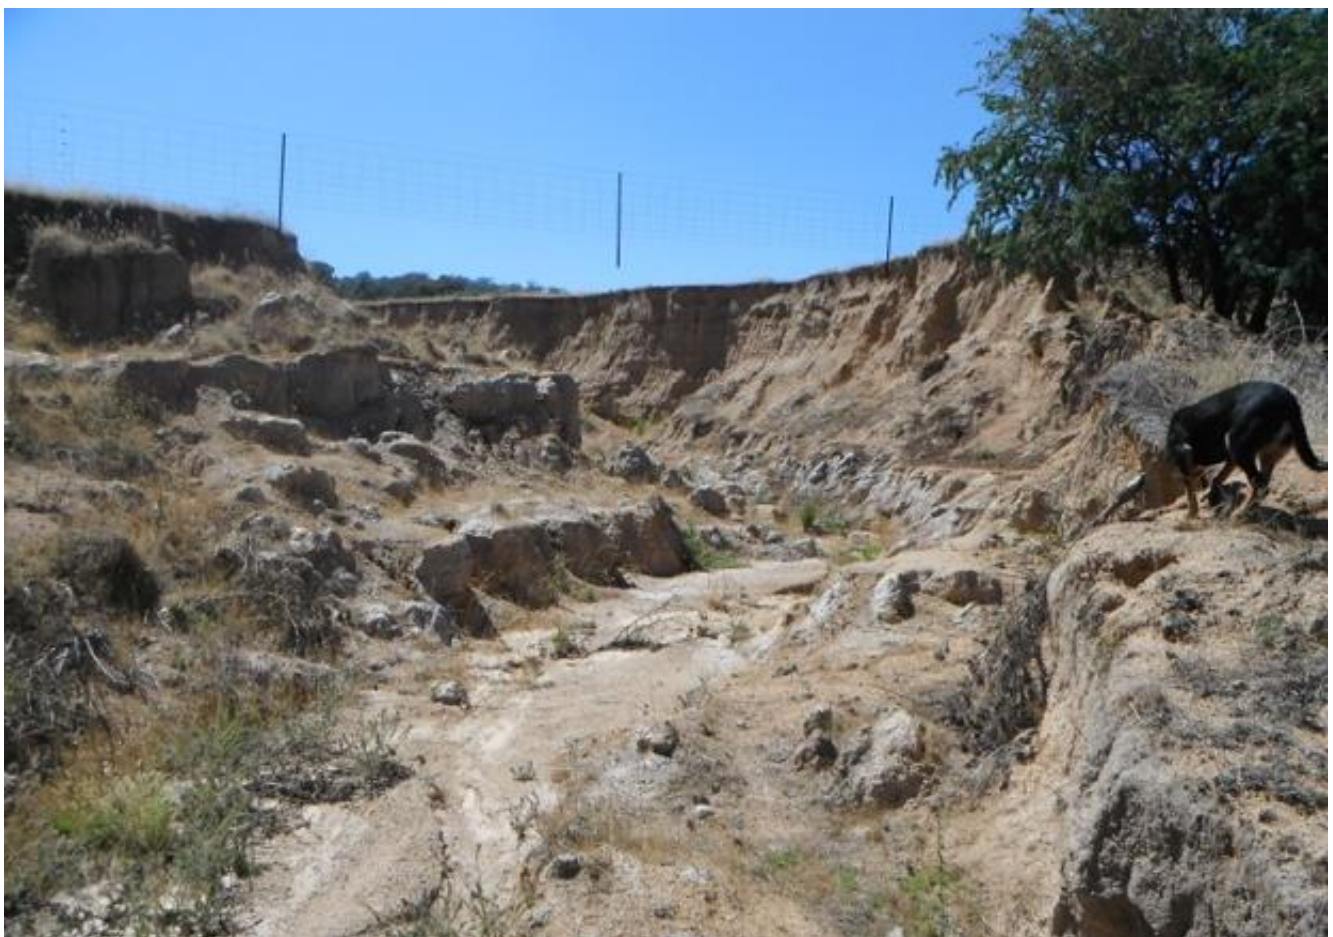
The photo below shows the upstream view of the southern gully from the original channel floor. The gully is setting itself to the 'base level' of the original channel floor.

Spillways should generally be designed for a 1 in 50 year event (Lewis, 2002), which is around 8.5 cubic metres per second for the 110 hectare catchment area feeding this dam. Based on this flow rate and a return slope of around 20% on the sidewall, the table in Appendix Two

indicates that an outlet width in excess of 40 metres would be required to safely convey this flow to the valley floor. This would need to be even wider if groundcover was poor. Clearly this was impractical from the beginning, so the dam was always in trouble when a big flow eventuated.

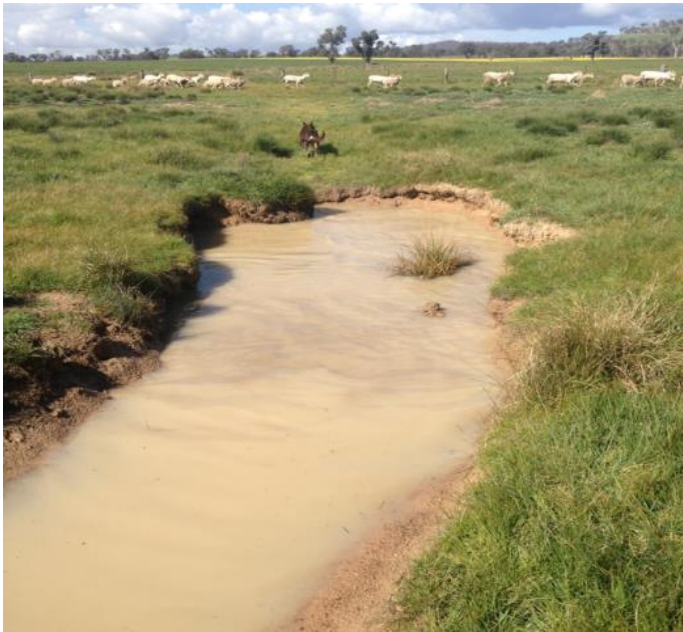
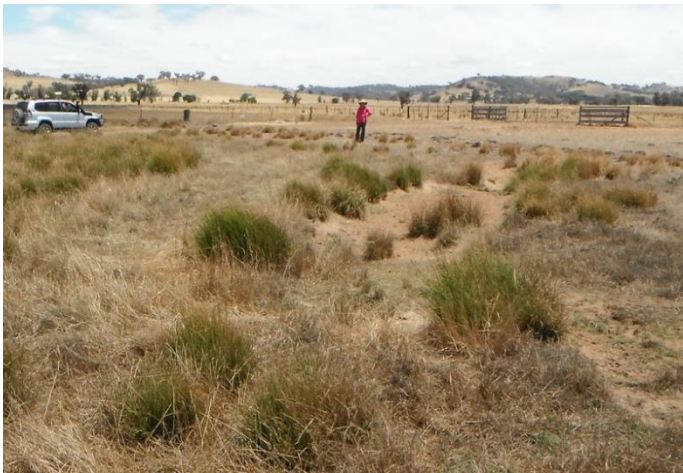
The overhanging lip of topsoil (seen in the top photo on the following page), and the cloudiness of the water (seen in the photo above, top) indicate the dispersive nature of the

Property:	'Ayrshire Park', Big Springs
Erosion:	Headcut migration and gully erosion
Causes:	Erodible soils
Catchment:	170 ha
Proposal:	Rock Rundown

To stabilise the headcut, a Rock Rundown is recommended. To resist a peak flow of approximately 2.5 cubic metres per second, an average rock diameter of 400 mm should suffice, using angular rock, with voids filled with small rocks and soil.

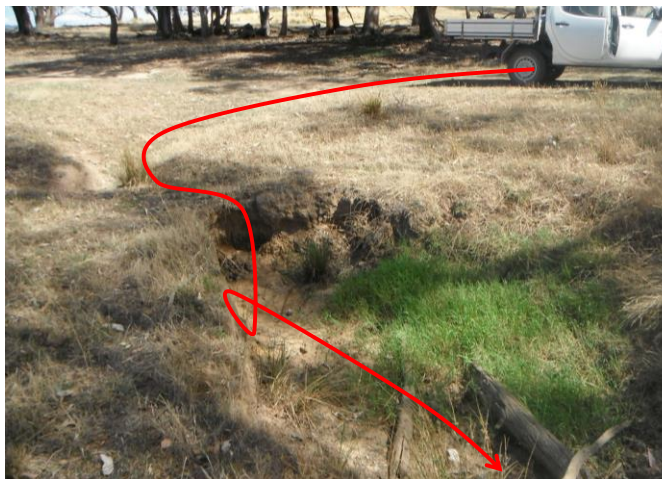
There are plans to add gravel to the crossing just above this site. In doing so, levels can quite easily be adjusted to encourage flow to head to the eastern side of the valley floor, rather than to the west as it currently flows, thereby starving the headcut. The valley floor is more level to the east, so subtle upstream diversion would result in more dispersed flow and re-entry, as indicated by the blue lines in the downstream photo (below) compared to the concentrated flow driving the existing headcut (shown by the red arrow in the photo below).

Within the proposed re-entry zone, there are two vulnerable sites at which minor erosion has occurred, leading to soil in the sidewalls becoming exposed. Armouring these sites, shown by the yellow lines in the photo above, with a Rock Rundown would be recommended, along

with One Rock Dams on the downstream side of these works, to create stilling basins along the re-entry zone.

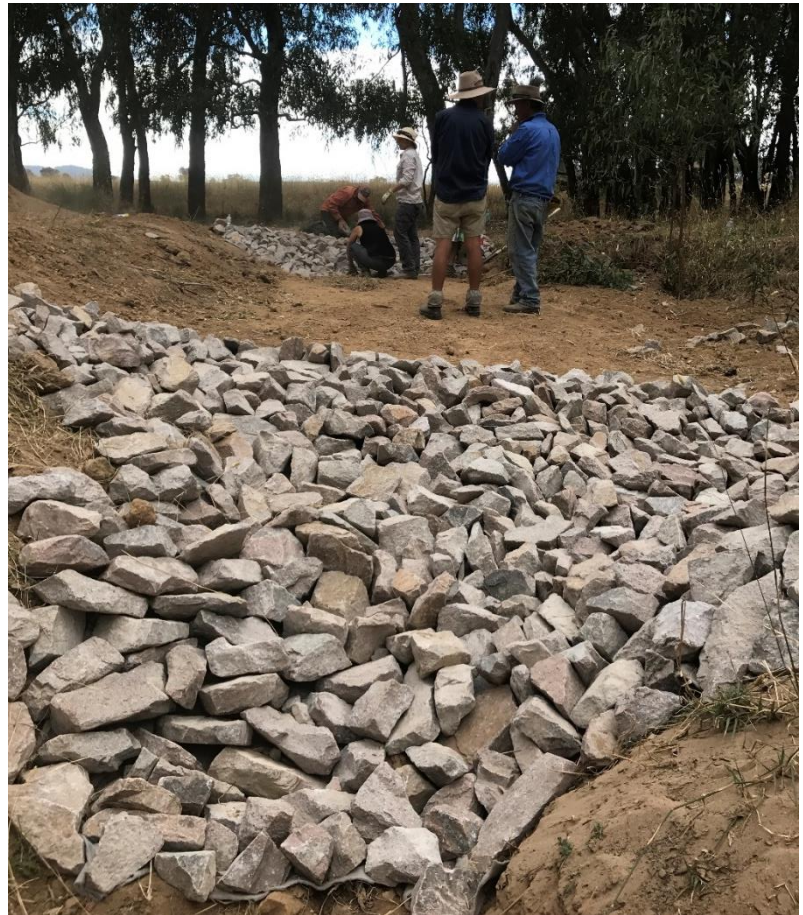
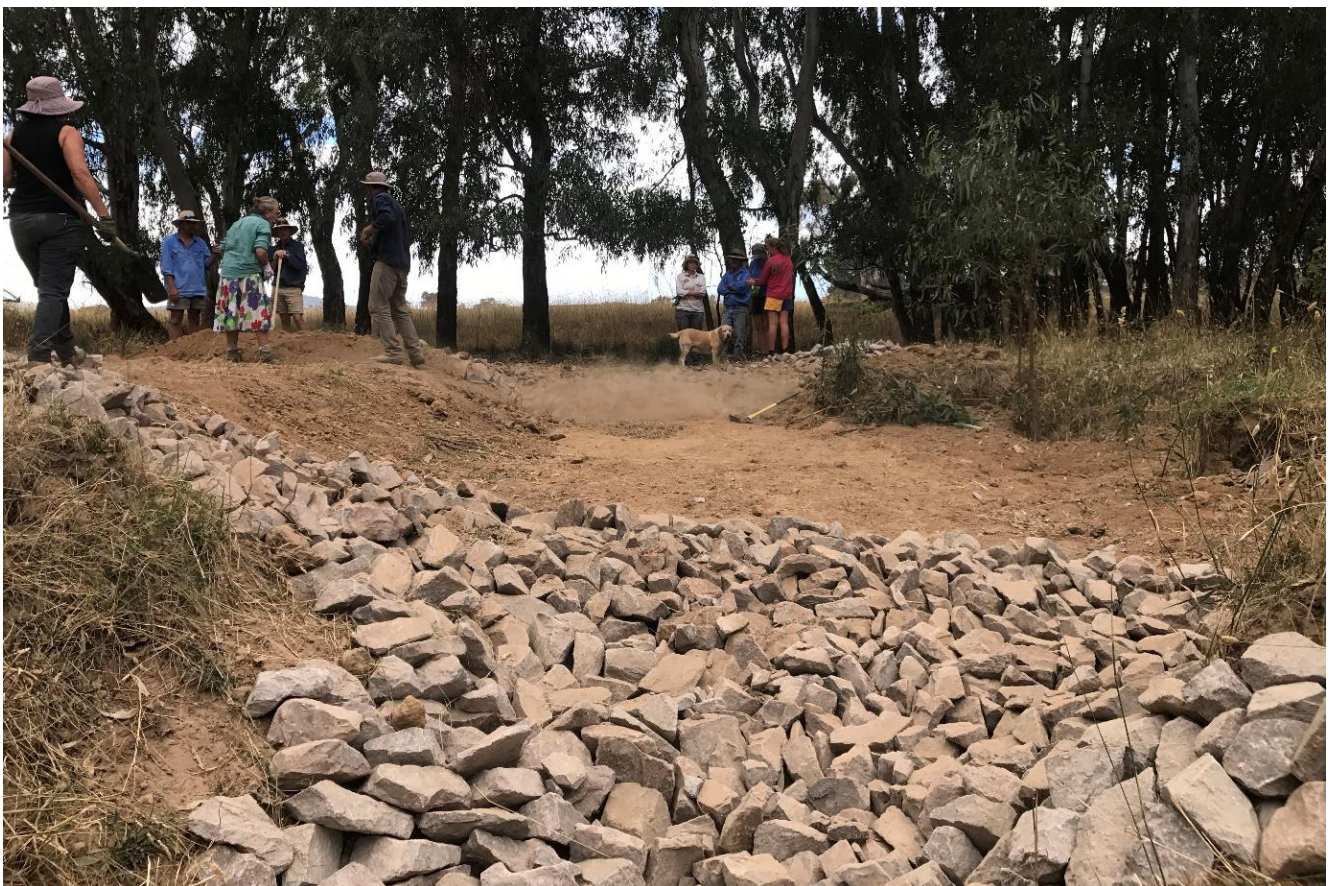
A standard headcut retreat process is occurring at this site, caused by overflow from the dam due to high rainfalls in recent years (see photo at top right). This has been exacerbated by the steep gradient down to the floor of Kyeamba Creek.

If the erosion continues and looks like it will advance past the stand of trees, armouring with a Rock Rundown would be recommended. The catchment area of 46 hectares results in expected flows of 1.7 cubic metres per second for a 1 in 20 year event, and 2.6 cubic metres per second for a 1 in 50 year event, based on the data in Appendix One. To resist flows of this velocity, a rock structure with an average rock diameter of 300 mm is recommended.

The landholders constructed a Rock Rundown (see photos at right and below), with geofabric lining below the rocks, and gypsum spread following construction. Seed was also spread to encourage establishment of vegetation at the site.

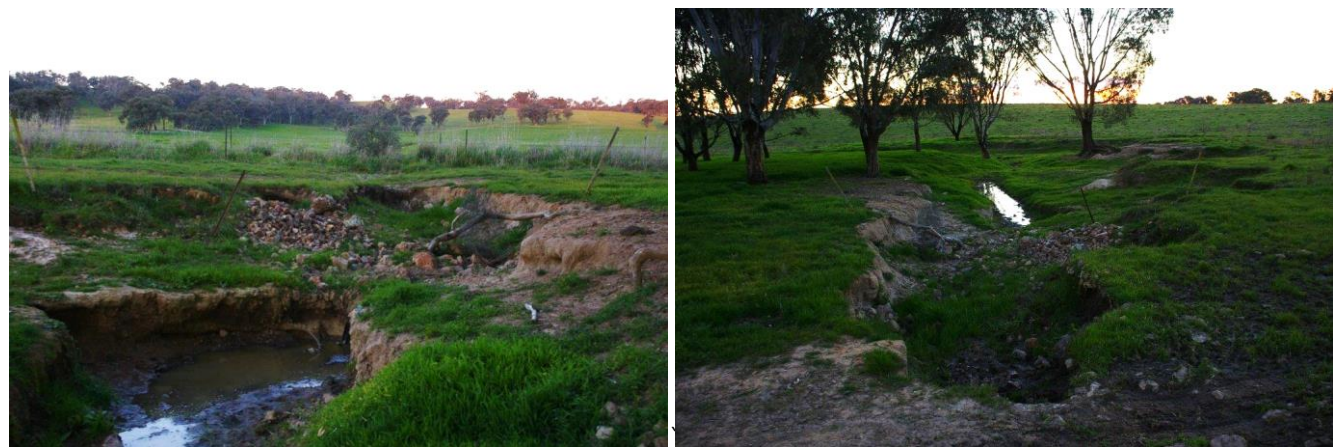
Site 10: Headcut retreat

The catchment is approximately 80 hectares, which will result in a peak discharge of 3.5 and 5.1 cubic metres per second for an Average Recurrence Interval of 20 and 50 years respectively.

Property:	'Wongoonoo', Book Book
Erosion:	Headcut migration
Cause:	Flow concentration
Catchment:	80 ha
Proposals:	Diversion Bank, Tyre Mattress, Tyre Step

Because of the height of the combined headcuts, and the significant flow rate at this site, rock armouring would require a large volume of material (over 15 cubic metres) and machinery-placement. As a result, starving the head with a dozer-built diversion bank will be a much more cost-effective solution. A channel five metres wide and 0.6 metres deep, set at a 1:200 gradient, will adequately convey a 1 in 50 year event. Design should be such that a level sill set 600 mm above the channel floor will allow larger flows to head around the northern flank.

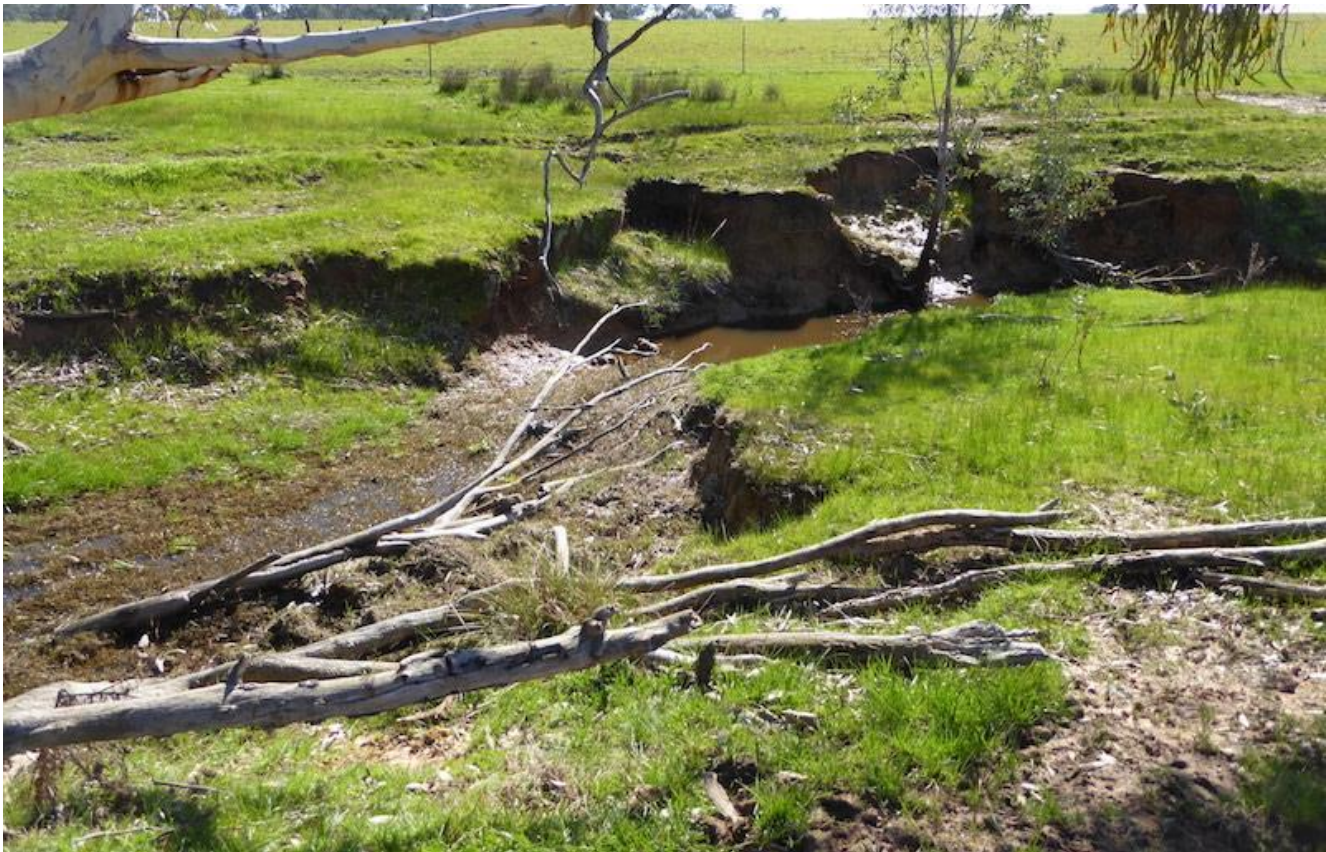
A further lowering of the bed has occurred more recently, that timing being indicated by the narrow profile and steep walls of the channel (following the downcutting stage). The ongoing bend erosion in multiple locations, such as that shown in the photo below, indicates that the widening process is still underway.

Undercutting caused by scour on the outside of the bend shown in the photo on the previous page has resulted in mass failure, with blocks of soil/sod sliding down the bank. This is a part of the ongoing widening process following a lowering of the bed. Vegetation within the channel and banks has been heavily grazed by stock, providing minimal flow resistance and preventing water loving plants from reaching their full potential

The formation of the meanders is actually moving the creek towards a more stable form. Bend erosion expends excess energy, while also increasing the length of the channel, which reduces the slope, thereby decreasing the velocity and erosive power over time.

Increased vegetation cover would significantly increase the roughness along the channel, thereby reducing stream velocity and the associated erosive power. Where erosion does continue as part of the ongoing widening process, the increased vegetation would help to retain that sediment as close to the source as possible. Once full in-stream wetland conditions establish, finer and finer sediment will begin to accumulate, which will offer multiple benefits to downstream waterways and ecosystems. This process of accumulation of fine sediments, following the establishment of dense in-stream vegetation, can be seen in the schematic below (from Zierholz, 2001).

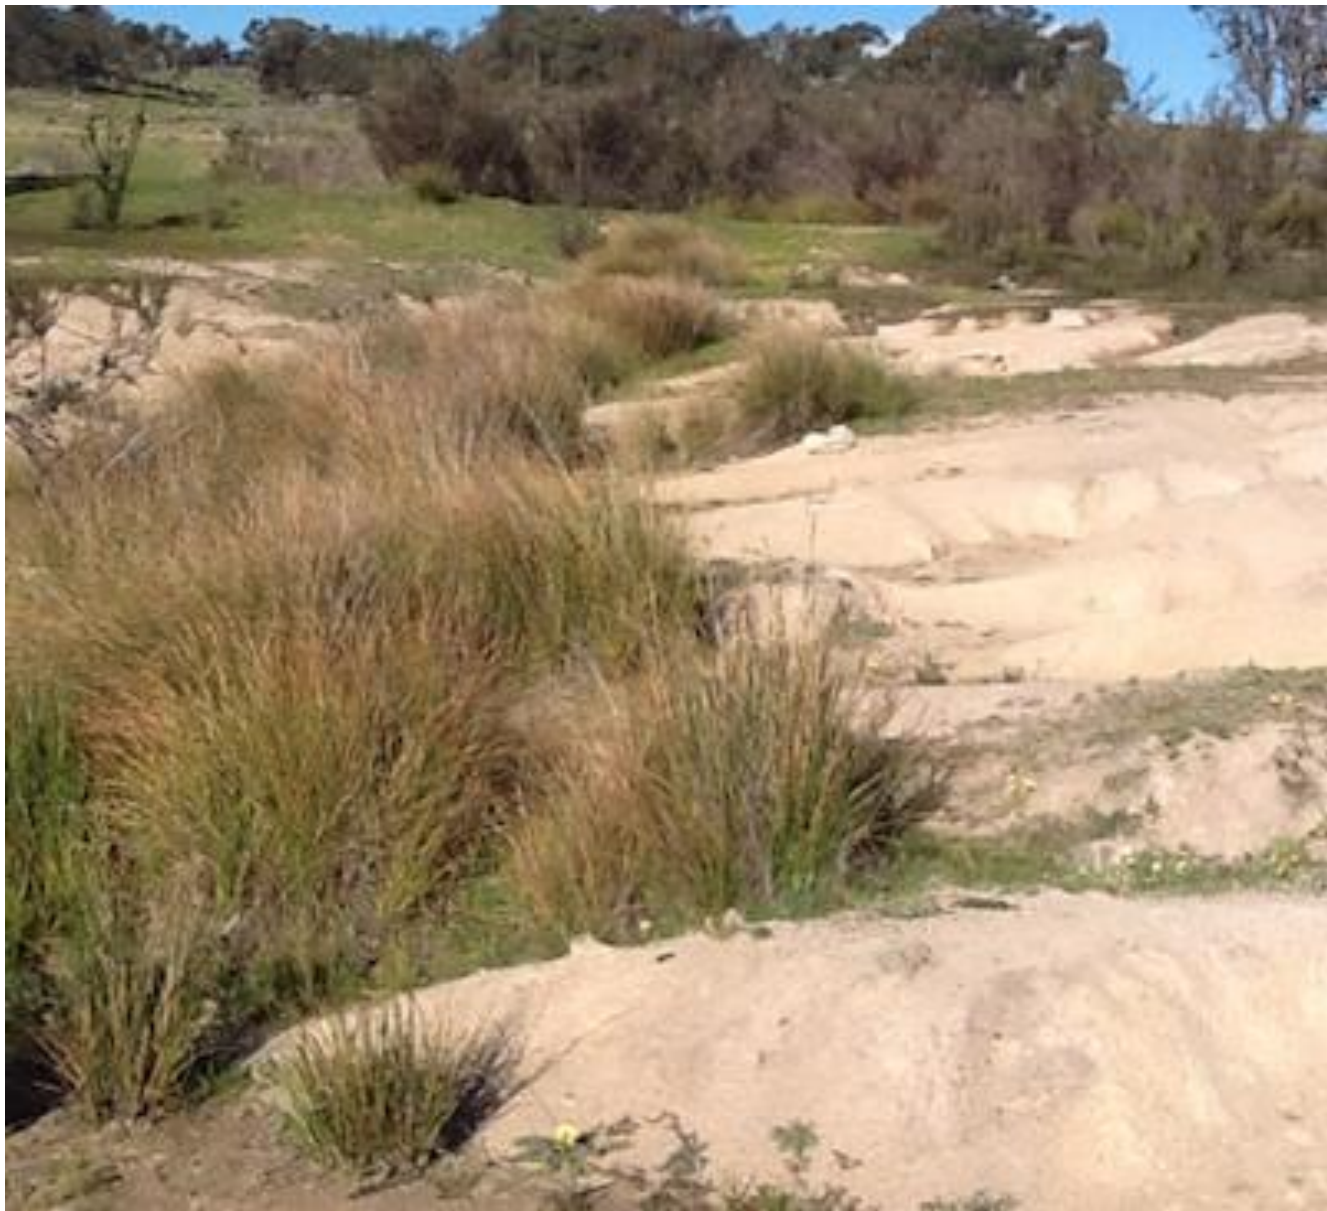
Site 12: Sidewall erosion in sodic soils

This site exhibits scalding (ongoing areas of bare soil) adjacent to old erosion gullies. This situation represents an extreme version of the battering process in stage 5 of the evolution of an incised channel. While sidewalls will often naturally revegetate once a moderate batter has been achieved (leading to stage 6 of the evolution process), the soil properties at this site are perpetuating sheet erosion and inhibiting vegetation establishment on the sidewalls, as can be seen in the photo below.

Property:	'Silver Springs', Big Springs
Erosion:	Channel incision & widening, gully erosion, scalding and sheet erosion
Causes:	Erodible sodic soils
Catchment:	58 ha
Proposals:	Brush Mattress, One Rock Dam

The subsoil is sodic and highly erodible, becoming very unstable and boggy when wet, and hard-setting when dry. Once exposed, these soils are prone to capping and the ongoing presence of a scald, as can be seen in the photo below. This is caused by inherently unstable clay particles being dislodged by direct rainfall impact, and then clogging the soil pores at the surface. Once capping occurs, infiltration is restricted, and the conditions become inhospitable for seed germination and vegetation establishment.

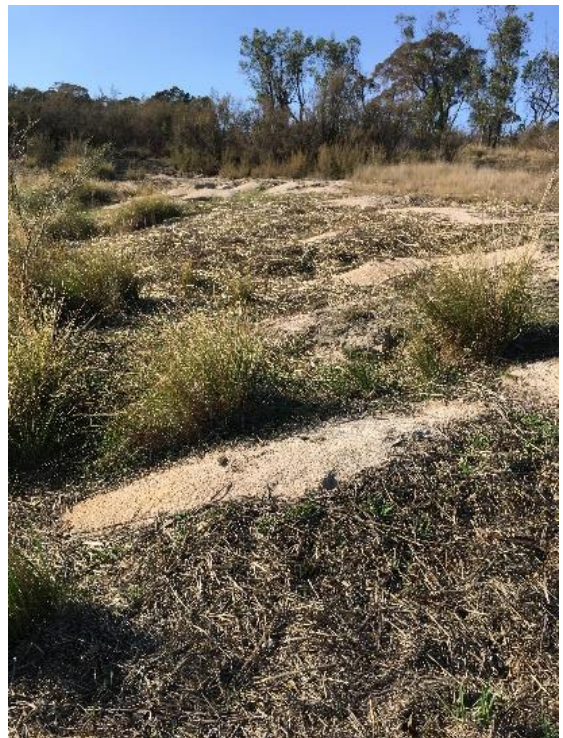
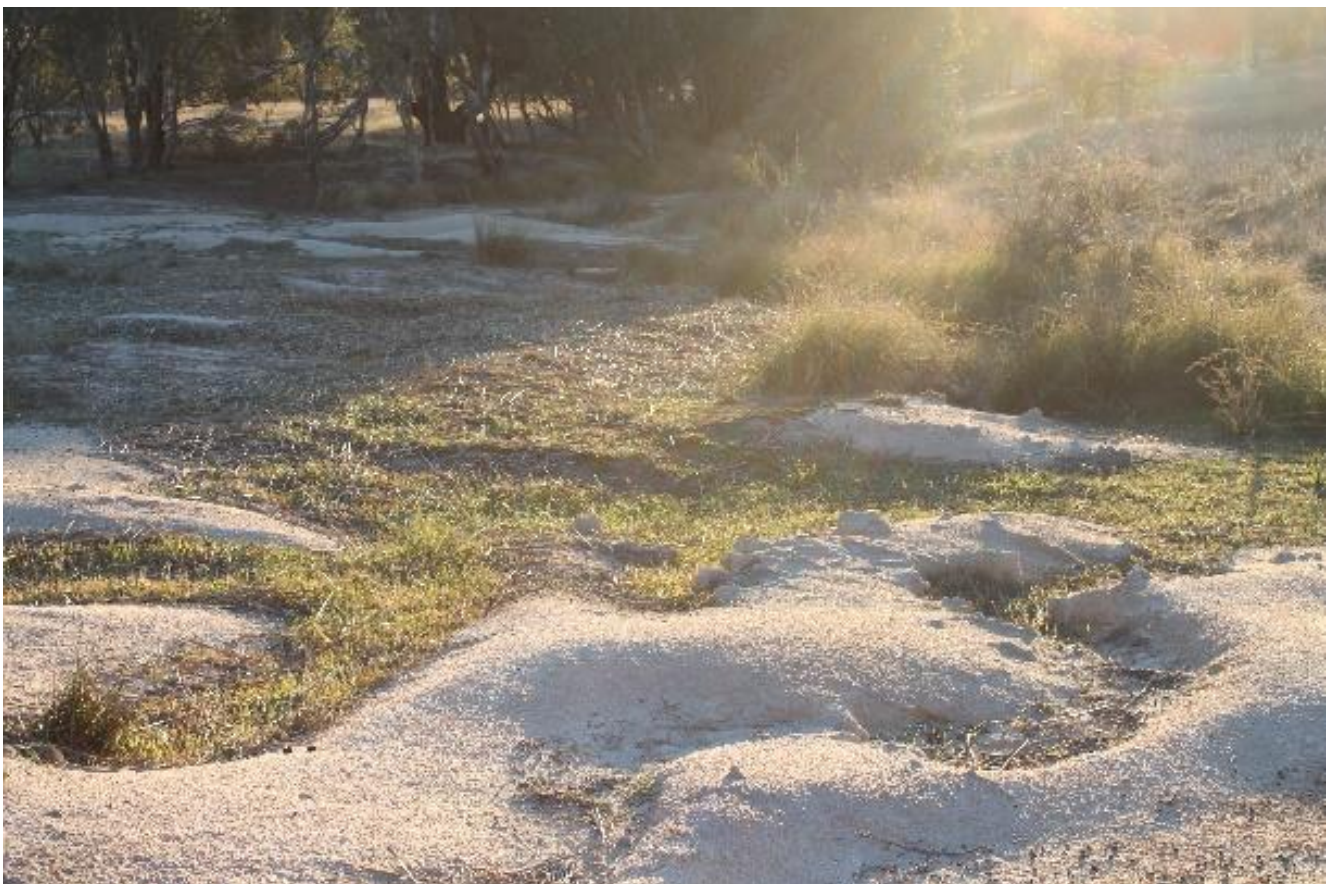
The landholders feel that the process has worked well on this relatively level site. The channels have been stabilized and grass is growing where there is good cover of hay. A final application of hay was added around six months after the initial application, to complete the coverage.

The landholders rolled out bales of oaten hay across the slope of the scald, and allowed sheep to graze and trample the hay for a short period (24 hours). This helped to break the crust of the scald, while the sheep also walked the hay (and sheep manure) into the surface as they moved across the area. The photos on this page show the site after these works, with the upstream view shown at right and the downstream view below.

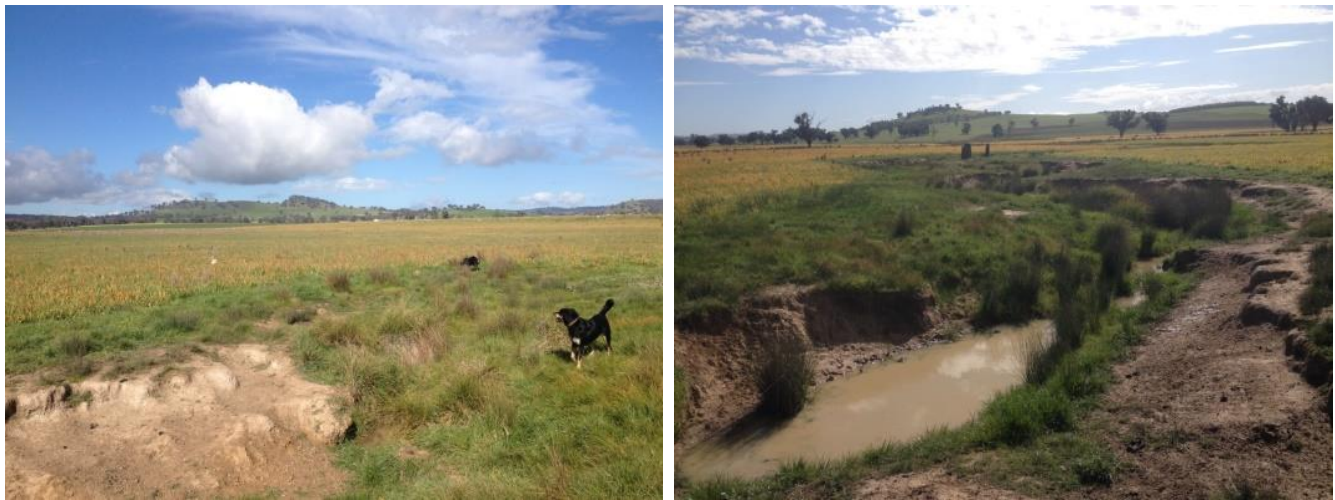
Site 13: Channel formation on a floodplain

The ramifications can differ considerably between grazing and cropping, with machinery access impacted far more than grazing. The photos below show the upstream view of the headcut and valley floor (left), and the downstream view of the channel that has formed (right), highlighting the impact on cropping area and access that is concerning the landholders.

Property:	'Aryshire Park', Big Springs
Erosion:	Headcut migration and channel incision
Causes:	Flow concentration and erodible soils
Catchment:	275 ha
Proposals:	Rock Rundown, fencing and revegetation

If the landholder comes to a decision that stabilisation is to be carried out, the considerable catchment area, of approximately 275 hectares, means that armouring with rock and fabric is the only viable solution. With peak flows of approximately 5.4 and 7.5 cubic metres per second for 1 in 20 and 1 in 50 year events respectively, expert advice should be sought for design and construction. It should also be noted that the Pillagala Creek at this site is a third order watercourse, and would therefore be treated as a river from a legislative perspective, requiring approval before any works were carried out (see Appendix Three).
