LOW COST EROSION CONTROL

CASE STUDIES IN THE KYEAMBA VALLEY

By Cam Wilson *for* Kyeamba Valley Landcare Group

This booklet was produced through the project
“Slow the Flow: Erosion Control in the Kyeamba Valley”,
funded by the NSW Environmental Trust

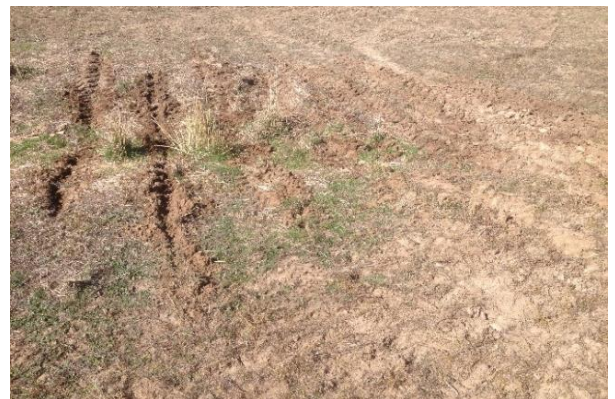
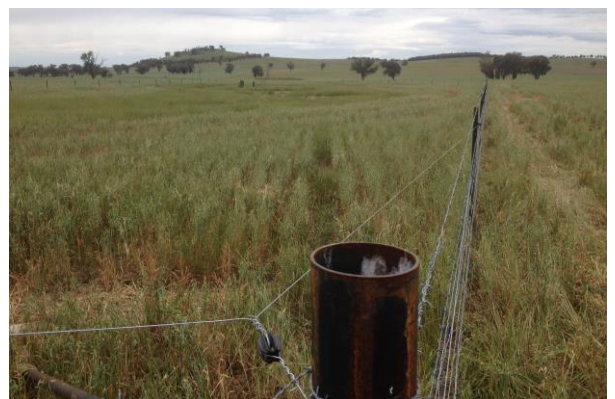
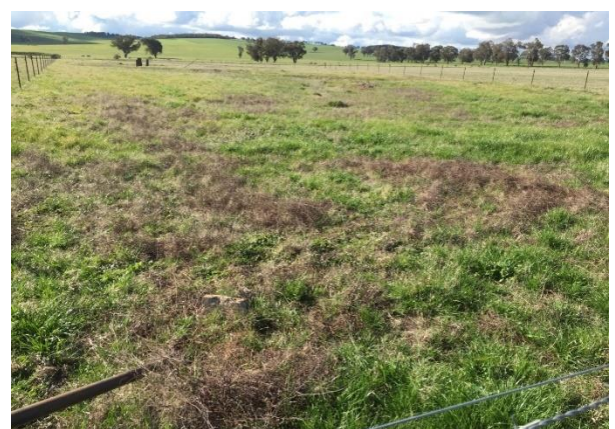
The landholders initially attempted to armour the site with two cardboard air conditioner pads at the erosion head. Unfortunately this was unsuccessful, as the pads were washed away in heavy rains approximately one year after installation.

Following this, the landholders decided to rip across the erosion head when quite wet, they then ripped and sprayed planting lines, fenced the entire area and planted with native seedlings. The result has been good stabilization of the site, with the fencing ensuring that stabilization and regeneration will continue. The series of photos above shows the site in May 2016 (top), October 2017 (middle) and July 2019 (bottom).

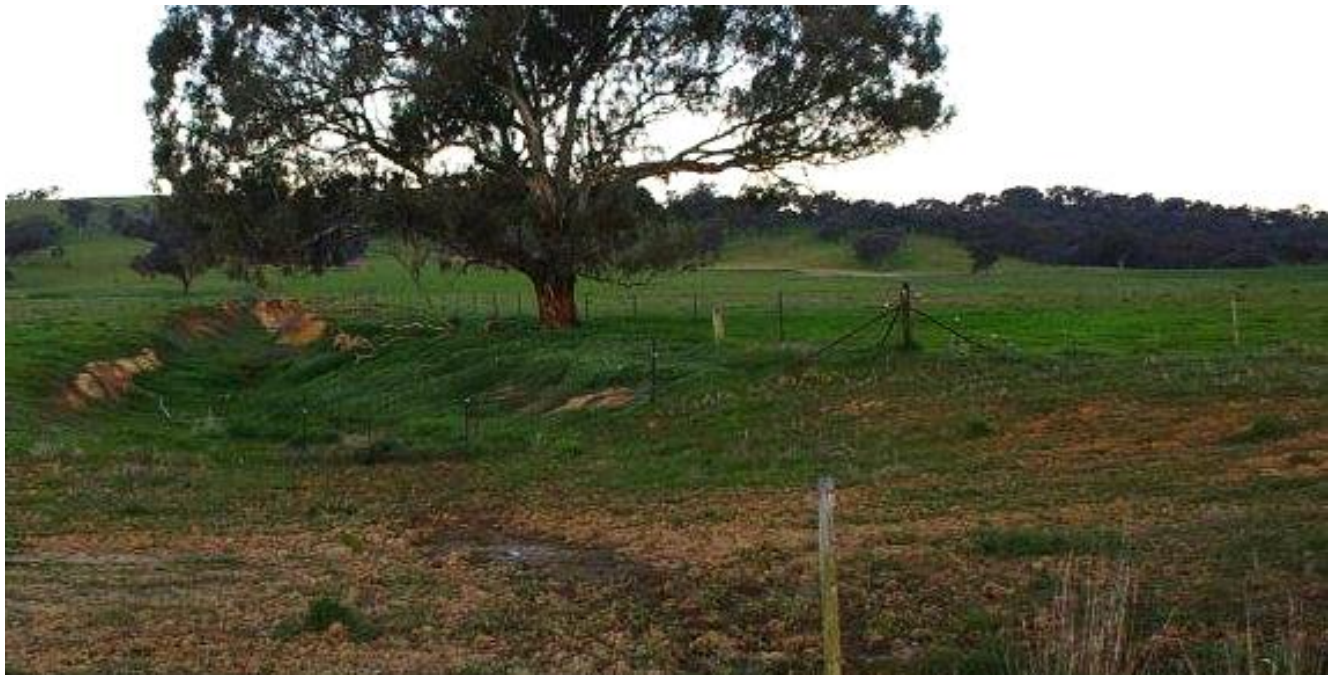
This site is of concern because further erosion threatens a main access route. The site is midway along an old gully, the linear nature of which generally indicates that it was caused by either an old road or a drain. The gully section within the laneway has been cut-and-filled to improve access, but flow heading over the crossing is starting to eat back into the fill, as can be seen in the upstream view shown in the photo below.

The catchment for this site is approximately 70 hectares, which can expect peak discharge of 3.1 and 4.6 cubic metres per second for an Average Recurrence Interval of 20 and 50 years respectively.

Without downstream armouring to protect the fill, or an adequate culvert pipe to convey flows, cut and fill to provide improved access within a gully such as this is always going to be threatened when overtopped.

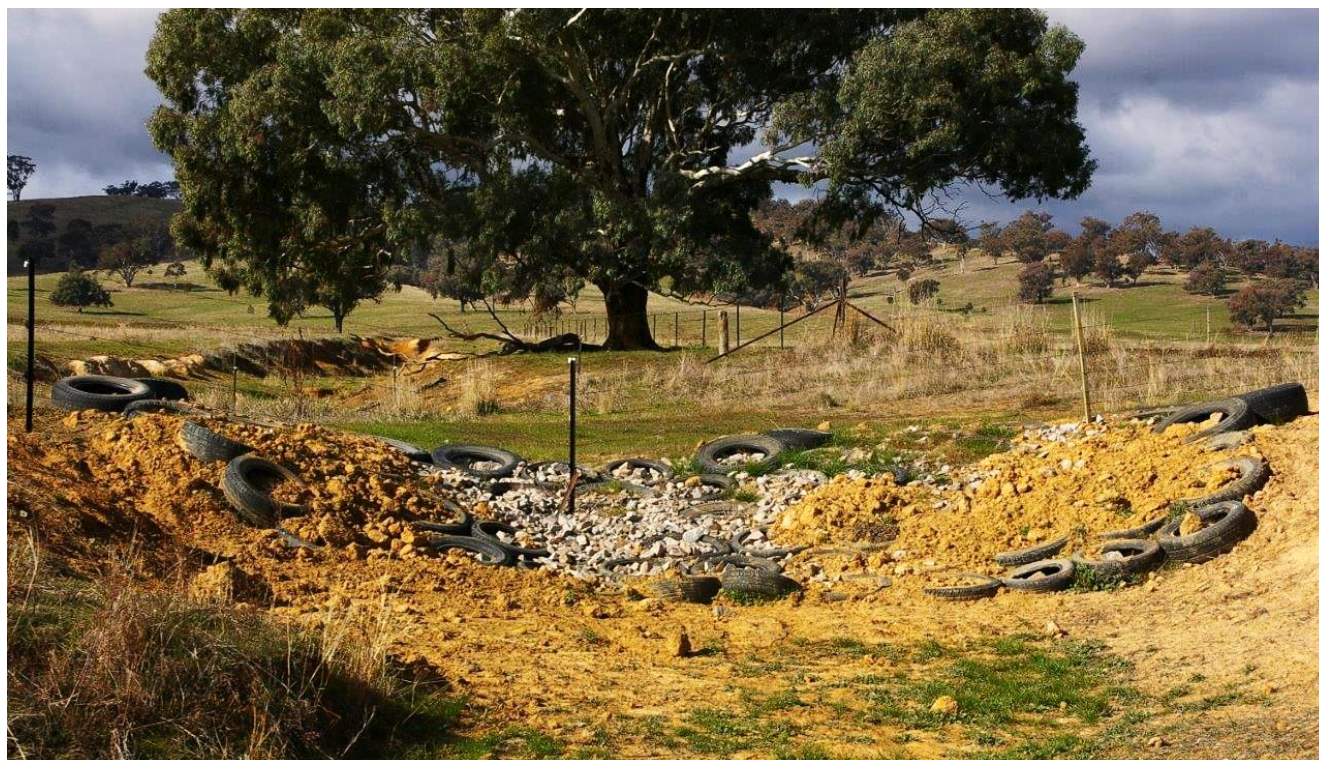
The landholders constructed a Tyre Mattress, with geofabric beneath the tyres and rock armouring the tyres, as the photo below shows. The site was fenced and revegetated with native seedlings, helping to stabilize the site.

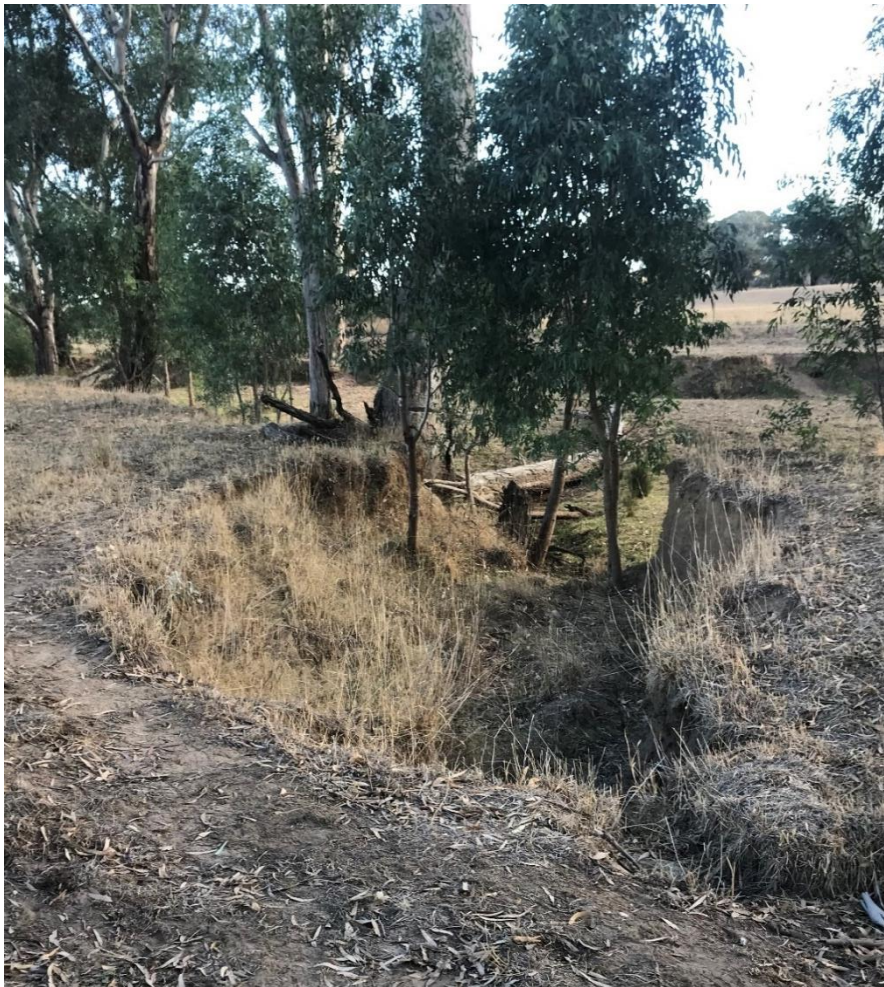
One of the first tasks when stabilising a gully, whether large or small, is to ensure that the floor is stable. The well vegetated floor, as can be seen in the photo at right, indicates that this has been achieved at this site. The establishment of the Eucalypts on either side of the descent is also a positive sign for reducing the chance of a further lowering from this point down.

The main task is therefore to armour the face of the active headcut. The large catchment area of around 311 hectares means that considerable flows are possible at this site, with peak discharge of 5.5 and 8.0 cubic metres per second expected for an Annual Recurrence Interval of 1 in 20 and 1 in 50 years, respectively. A Rock Rundown would therefore be the recommended approach, with the appropriate rock size being dependent on the proportion of flow that is heading over the site. Assuming around half of the overflow heads over the site, and a 2.5 metre wide flume is constructed (equivalent to the approximate width of the

channel downstream), an average rock diameter of 450 mm would be required to resist a 1 in 20 year event (Catchments and Creeks, 2010). If the rock is carefully keyed from the base up and voids are filled with smaller stone and soil, a slightly smaller average rock diameter of around 300 mm could be utilised.

Because of the flow volume and velocity, professional advice is highly recommended for this site.

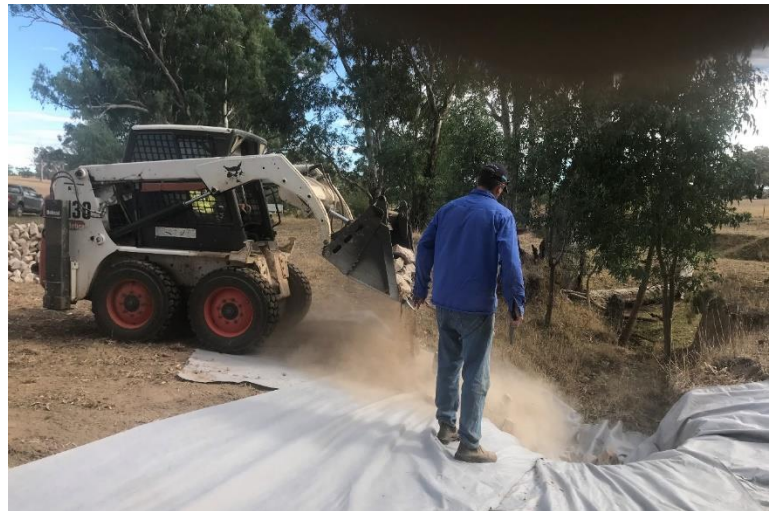
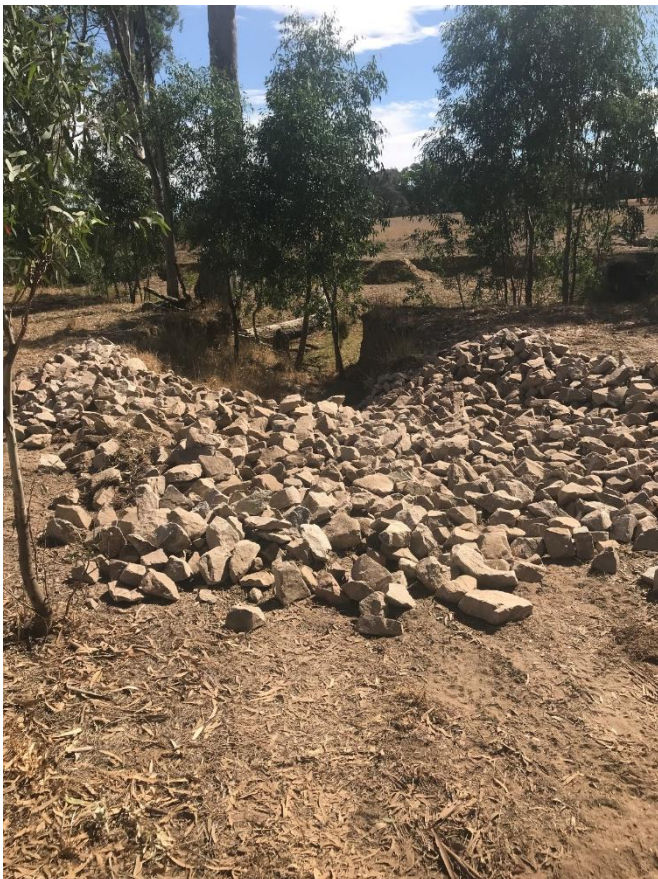
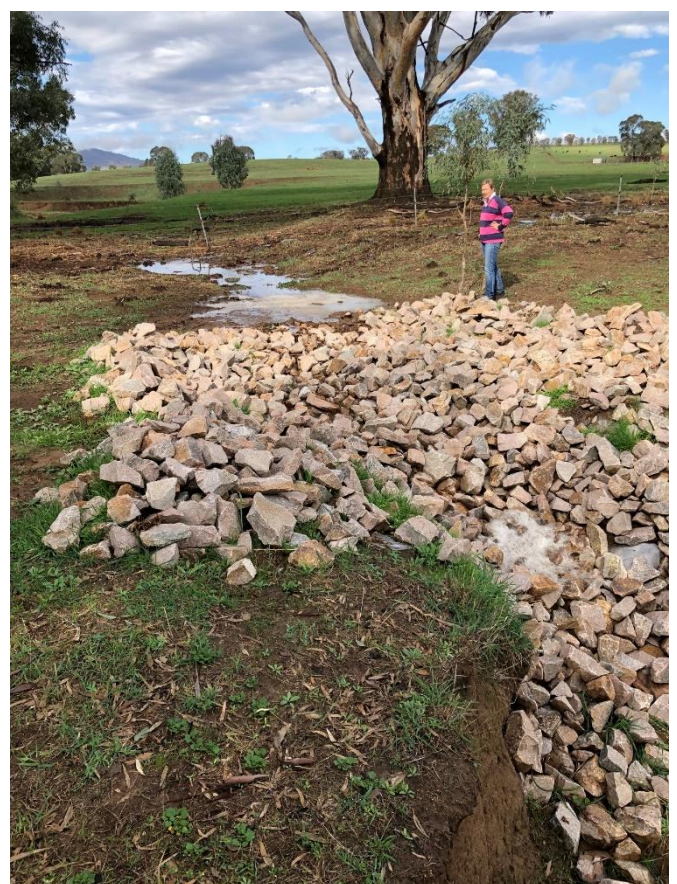
The landholders lined the site with geofabric, as shown in the photo at right, then armoured it with a Rock Rundown (below left) using rock of 150 - 300 mm diameter. As can be seen in the photo at below right, the structure has worked well in recent rains.

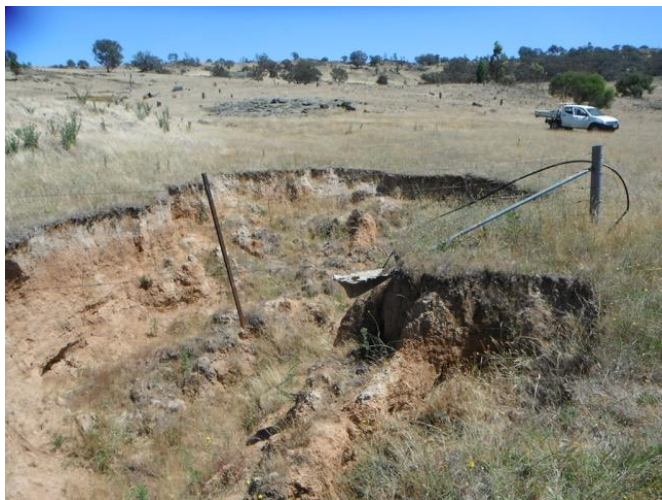
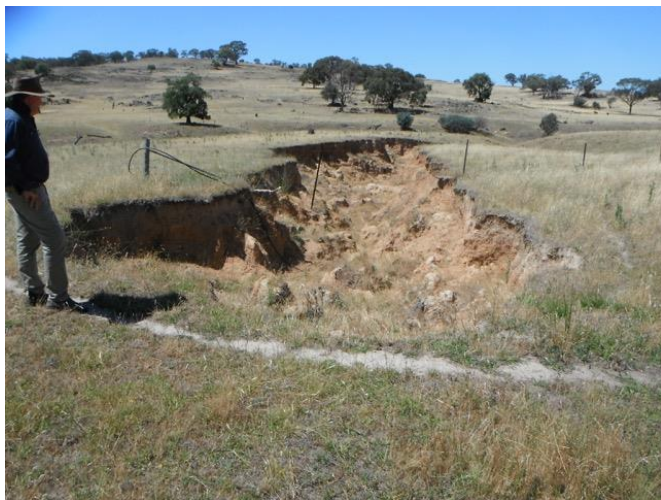
Site 16: Erosion of an old stabilised gully following a major storm

A dam with a 14 hectare catchment overflowed during a major stormflow event, commencing a new sequence of gully erosion at the point that it re-entered an old stabilised gully. This resulted in the erosion gully seen in the upstream (left) and downstream (right) photos below.

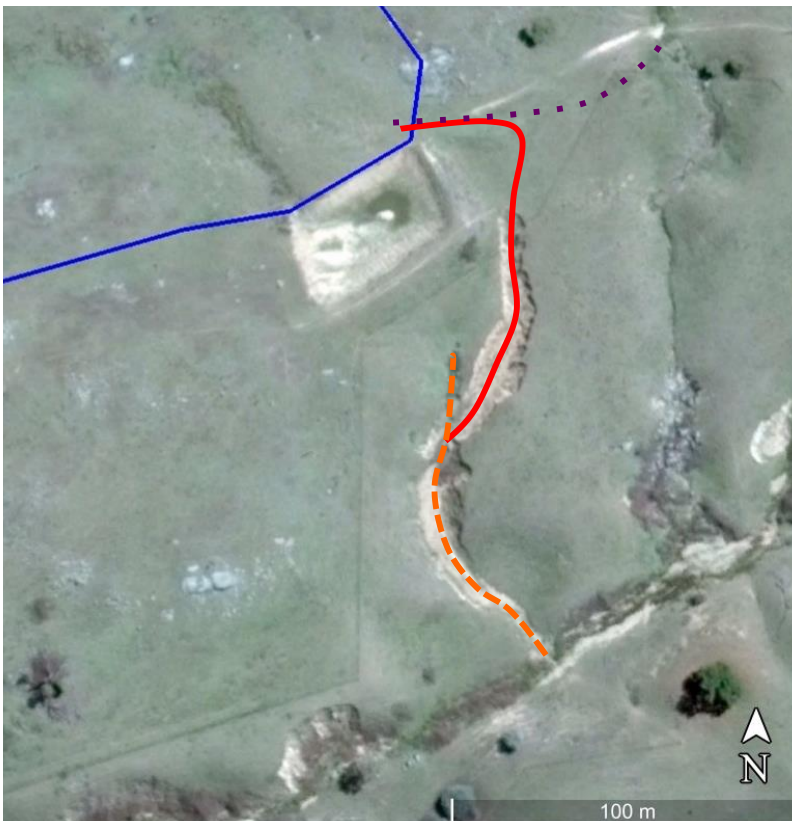
The aerial view of the site, at right, shows the process, whereby the major overflow event (shown by the red line) initiated a new headcut where it dropped down the sidewall into an old stabilised gully (indicated by the orange dashes).

The dam seen in the aerial view on the previous page does not overflow often; it leaks quite readily, which results in a reasonable proportion of the approximately three megalitres usually needing to fill before overflow occurs.

For the option described above to be successful, a sufficient period for root systems to establish without major flows would be required. If the headcut starts to rapidly migrate again, threatening the dam, then the installation of a contour to redirect flows across to the valley to the east is advisable. This valley has already incised as far as it can go, having hit bedrock and boulders in multiple locations. If a dozer were completing earthworks nearby, this would be a sensible piece of earthworks to complement the vegetation approach described above.

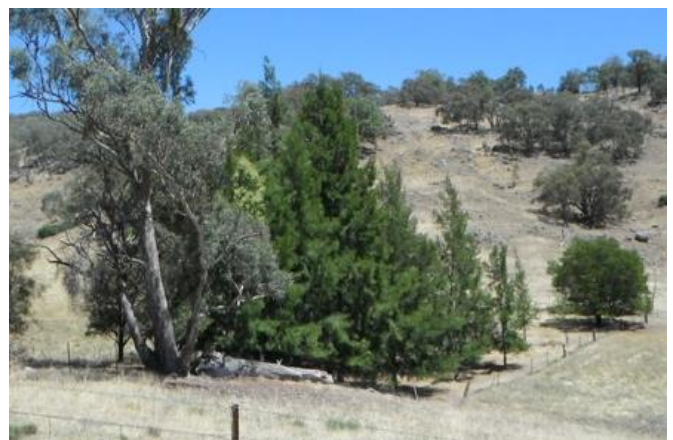
Casuarina cunninghamiana, which is performing well over the hill (see photo at right), is the native tree species that has the most suitable root system for such purposes. Depending on species preferences, landholders in New Zealand have achieved good levels of success using poplar species as an erosion control tool in similar circumstances (see Charlton et al, 2007).

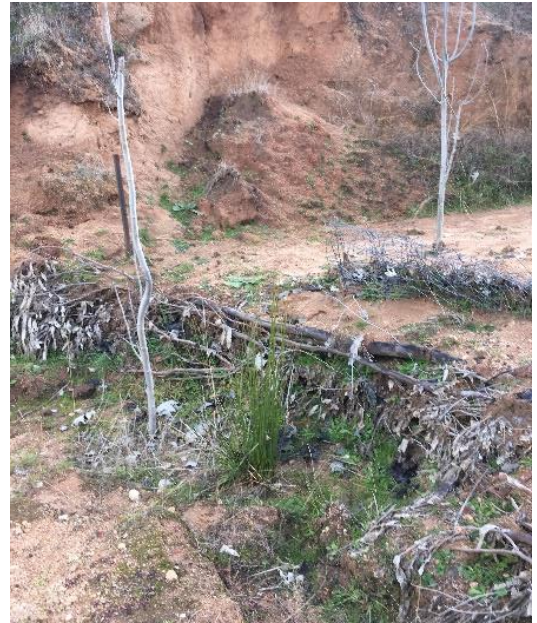
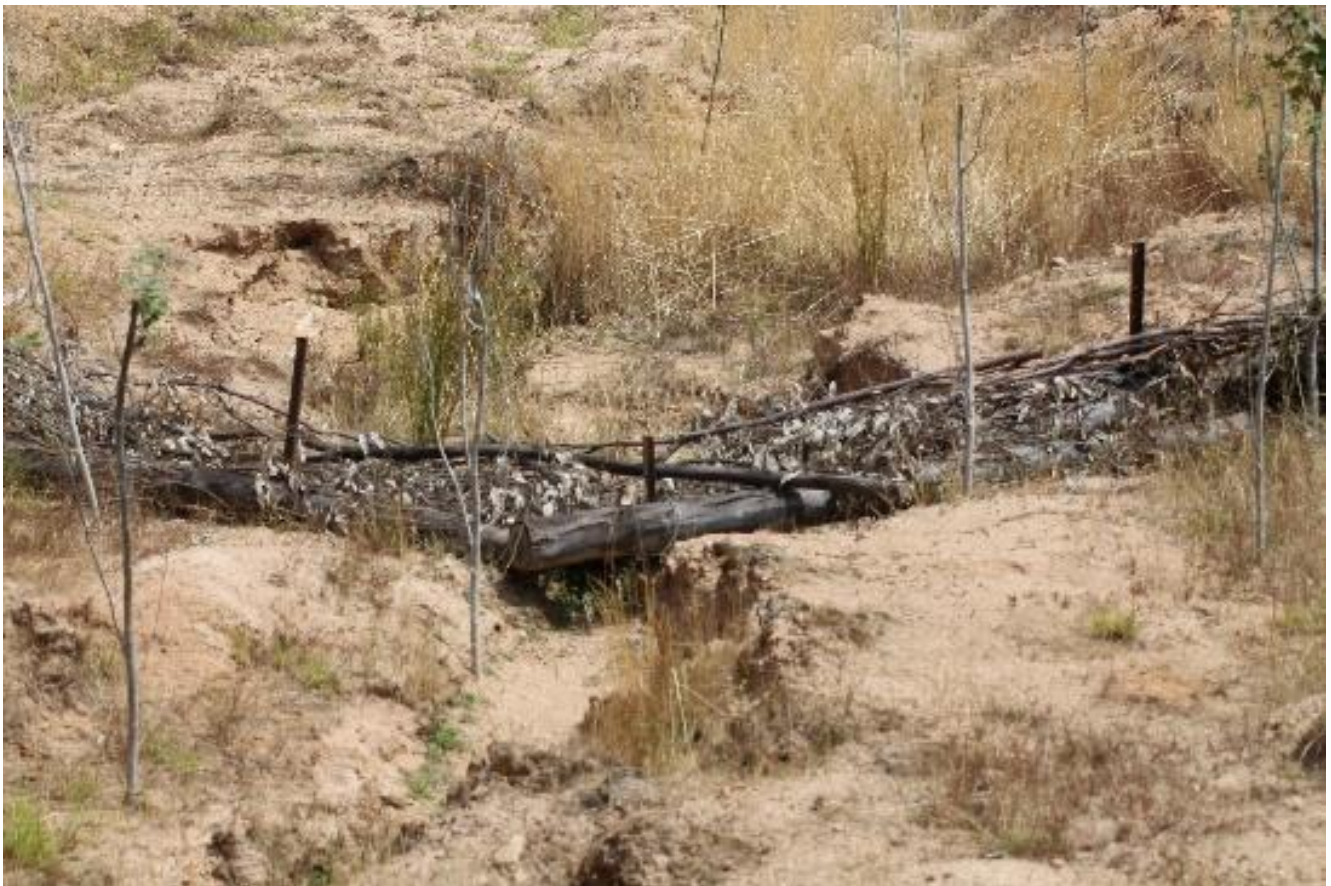
During a rain event a few months after construction, the trickle pipe for the dam adjacent to the gully was blocked by a dead turtle. This caused the dam to overflow out into the active gully, tearing away the work which had been completed.

The photos at right and below show the site one year after the overflow event, with many saplings still visible, and sediment capture evident.

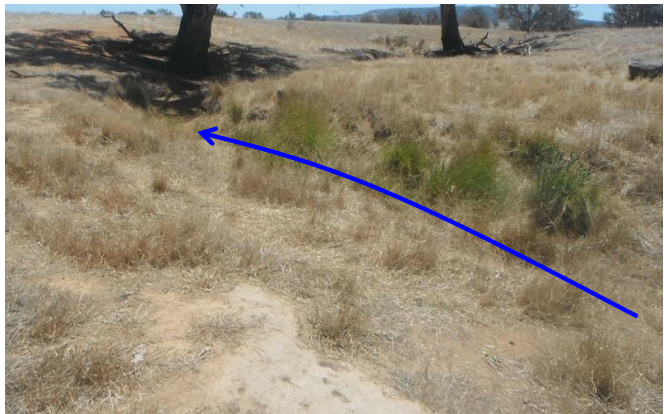
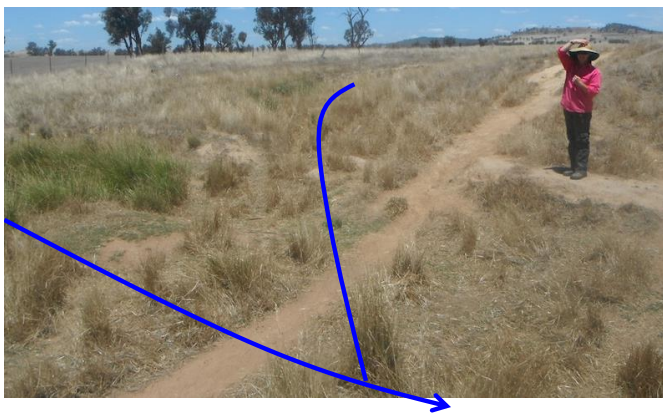
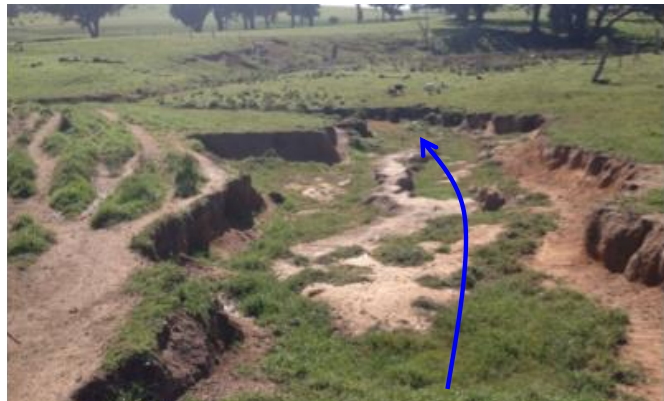
Site 17: Retreating gully erosion along tributary

The stability of the floor of the channel at this site is related to downstream conditions. The main creek is stable and well vegetated with sedges present (top right). The downstream end of the small gully enters the creek smoothly (middle right), while the rest of the channel is reasonably well vegetated with quite an even grade (bottom right). With conservative grazing, there is little risk of further lowering of the channel floor, other than the small island in the centre.

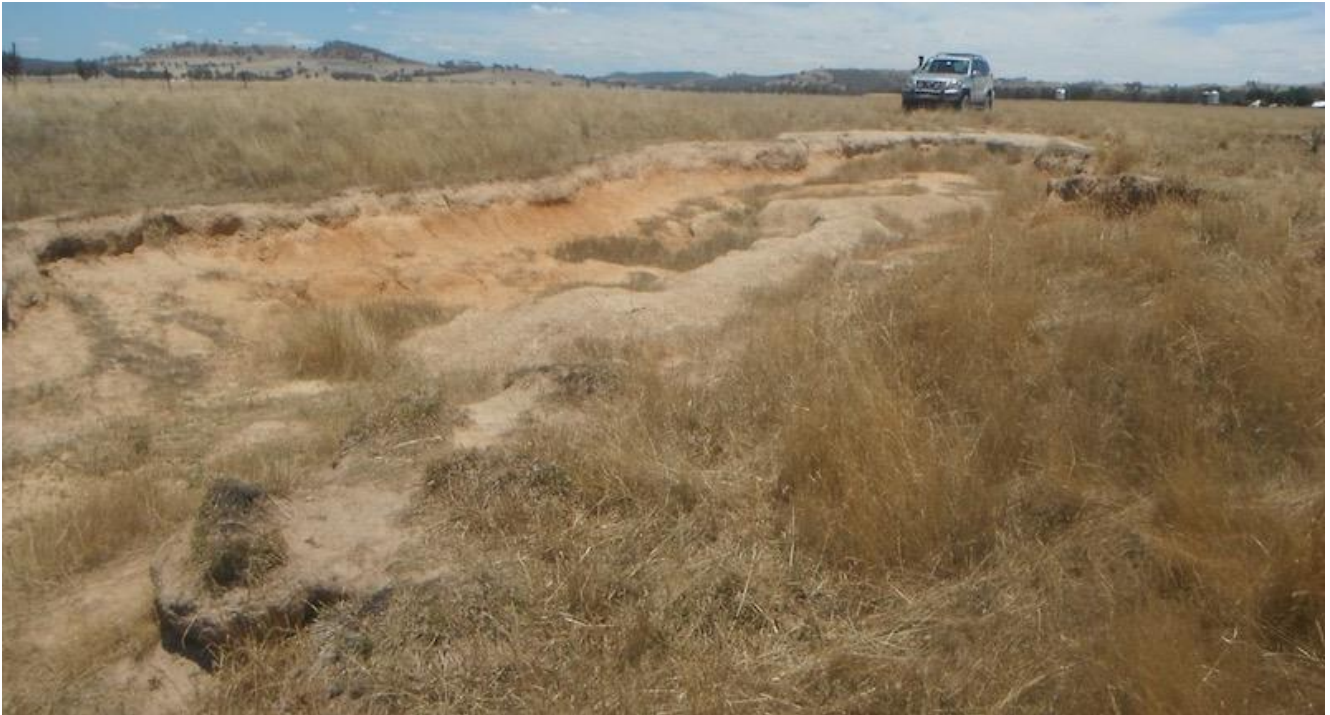
The walls of the gully have quite a visual impact, as can be seen in the photo on the following page of the upstream view of the headcut and gully (the edge of the dam is to the right of this photograph). However the

appearance of the gully walls is predominantly a cosmetic feature and will naturally batter in relation to the channel floor and revegetate over time, following the natural sequence of the evolution of an incised channel. Addressing the head of the channel is the main requirement at this site.

The level of priority for stabilising the head is determined by how important this particular water supply is to overall grazing management. If the gully is left unmanaged, the overflow is not likely to lower more than the depth of the existing 0.5 metre deep gully, which represents a decreased storage volume of approximately 0.25 megalitres. One additional concern if this eventuates however, is that a lowering of the full supply level in the dam may cause a new phase of erosion to initiate upstream of the dam, due to a reduced 'drowning out' extent. Armouring of the site is therefore recommended.

While this is only a second order watercourse and therefore doesn't require approval, due to the scale it would be recommended that professional advice be sought in designing and constructing such works. As a ballpark, a five metre wide chute (equivalent to the width of the current face) with a 1-in-5 grade would require an average rock diameter of around 400 mm if angular, and 550 mm if rounded.

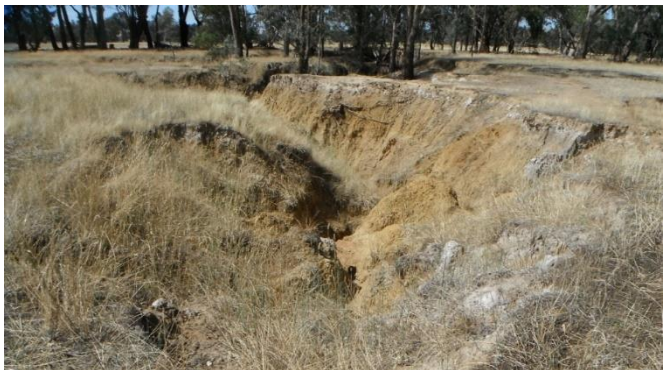
This site is a very large-scale example of the tributary retreat process. The main channel is approximately four metres deep. As can be seen in the photo at right, the subsoil on the walls is sodic and highly erodible. The sloping sod in the foreground of the photo indicates that flow is running across the floodplain surface, over the lip of the more resistant topsoil (A horizon) and then onto the subsoil (B horizon) which is dispersing and washing away underneath, causing the sod to progressively collapse in.

This is a very challenging site to address. The cost of hard engineering, such as with a rock or concrete flume, would be very difficult to justify at a site like this due to the scale and episodic nature of the movement - it takes a very wet period for sufficient runoff to occur.

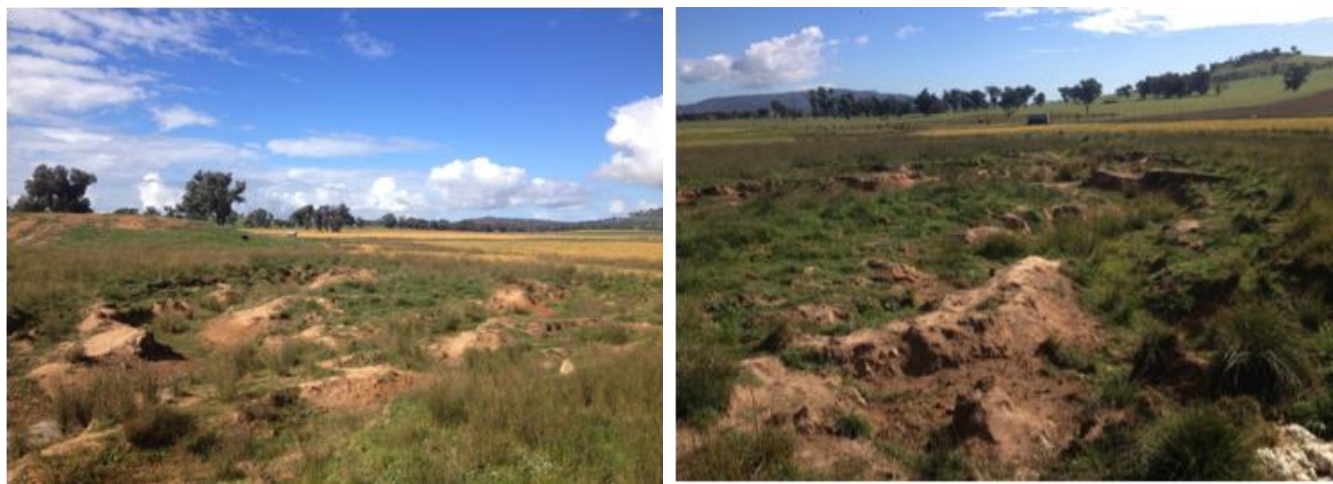
Multiple active headcuts are retreating within the overflow zone of a dam on Pillagala creek. The photos below show the upstream view of the active erosion face in the dam overflow zone (below left), and the downstream view from one of the active headcuts (below right).

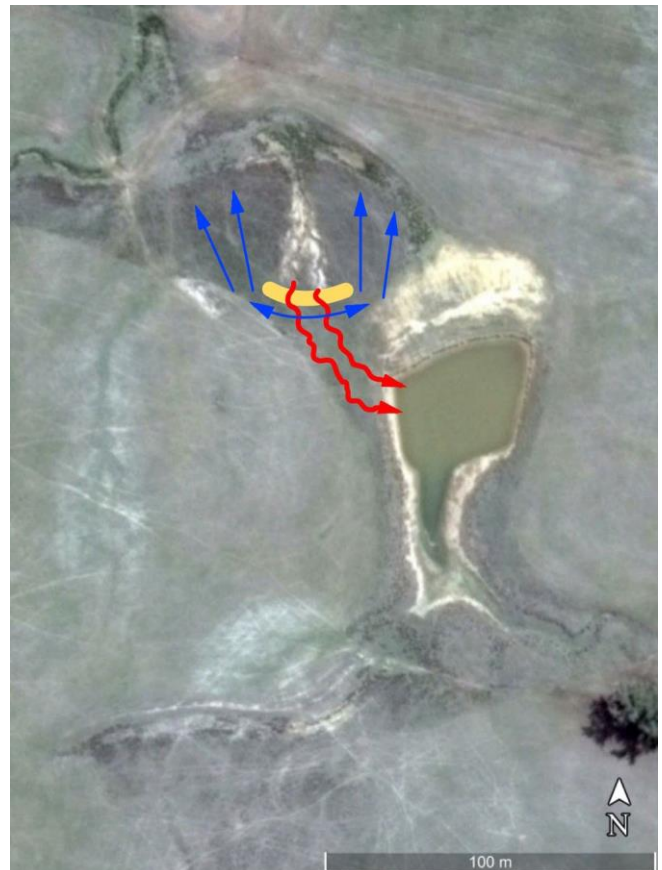
The headcut initiated at the site where flow re-enters the original channel. The aerial image on the following page shows the path that the erosion will take if left unmanaged (shown by the red arrows), continuing to migrate back towards the dam. There are multiple active headcuts within the channel itself, which threaten to further lower the bed over time

main channel. Reinstating dispersed flow across the zones indicated by the blue arrows in the aerial photo will help to give this area the best chance of long-term stability. This would best be achieved in combination with the strategies of groundcover management and early intervention.

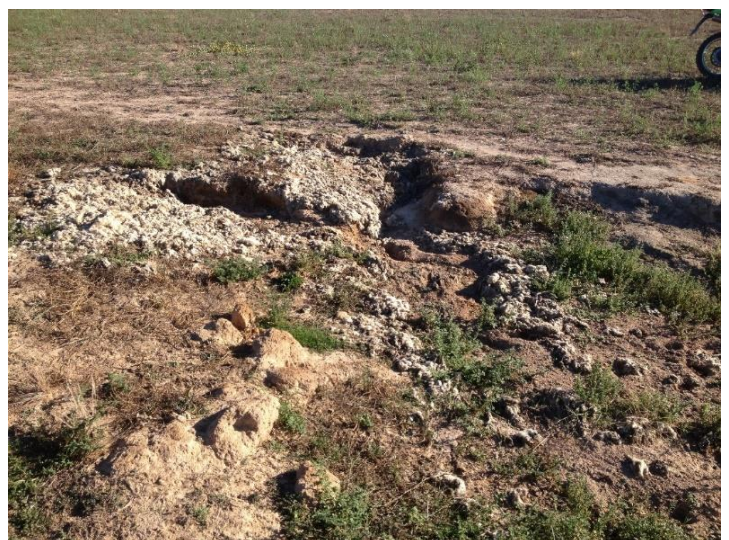
The landholders initially filled erosion heads with dags and crutchings, as can be seen in the photo at right. They found this to work relatively well, although they believe more time is needed for seed germination and growth before heavy rains, as this tends to wash away the wool.

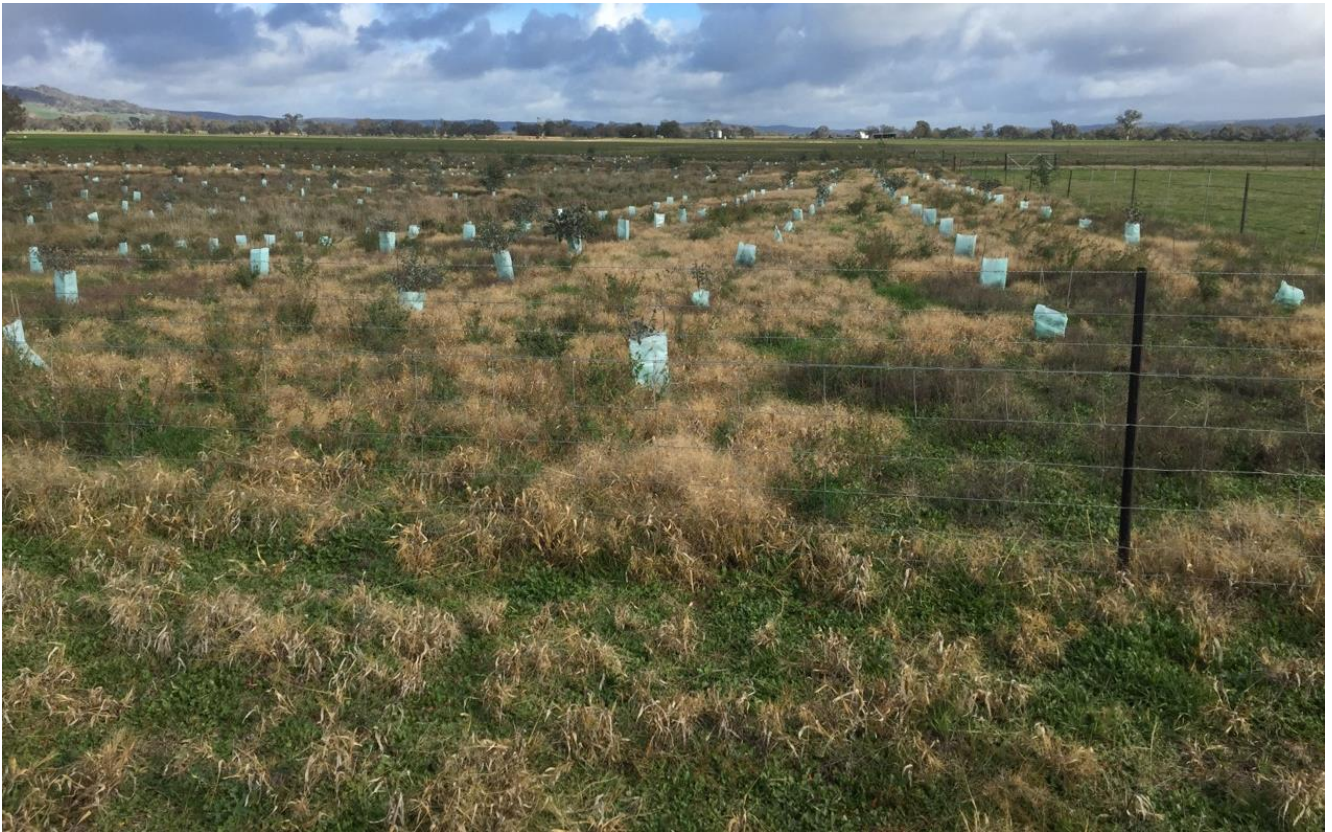
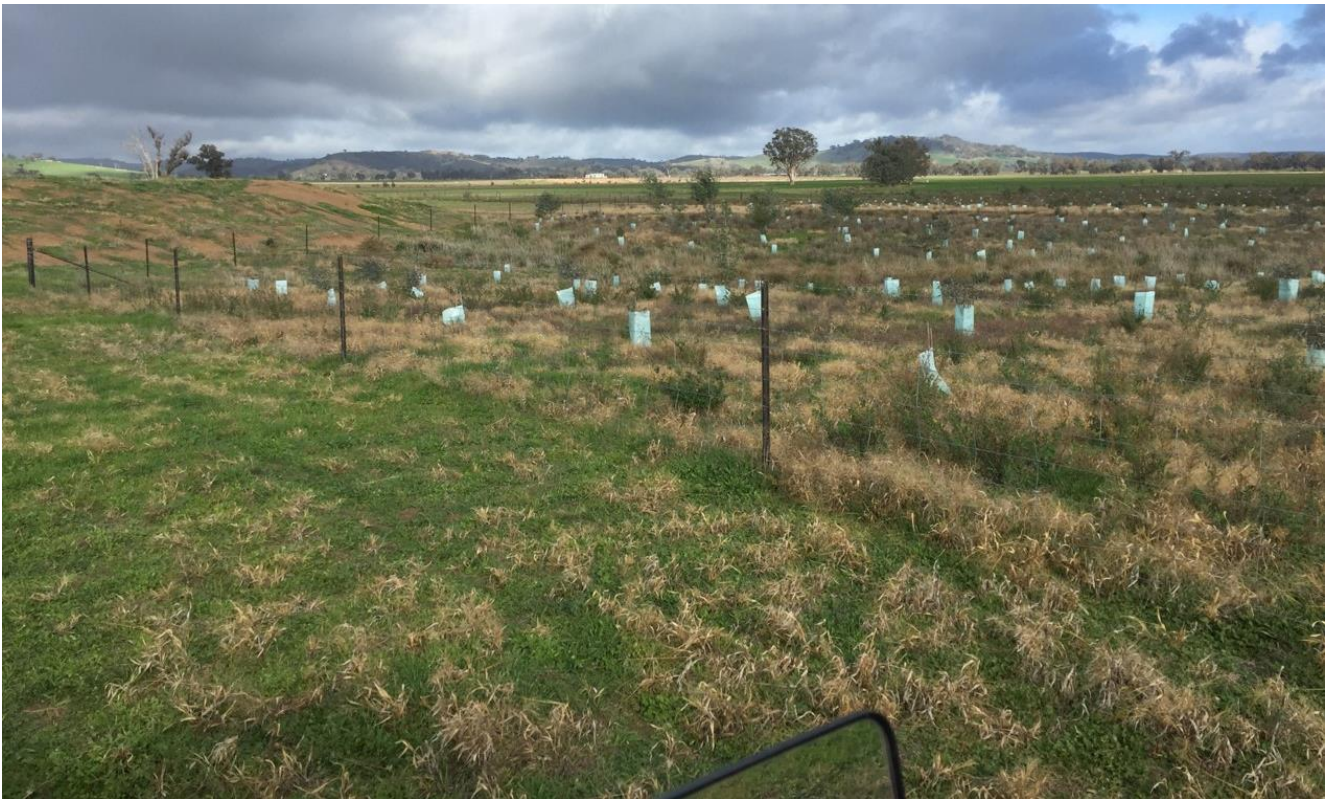
The landholders subsequently fenced the site out, and planted it out to make a wetland tree plot, as can be seen in the

photos below. The dam bank can be seen on the left of the shot in the photo at the bottom of this page.

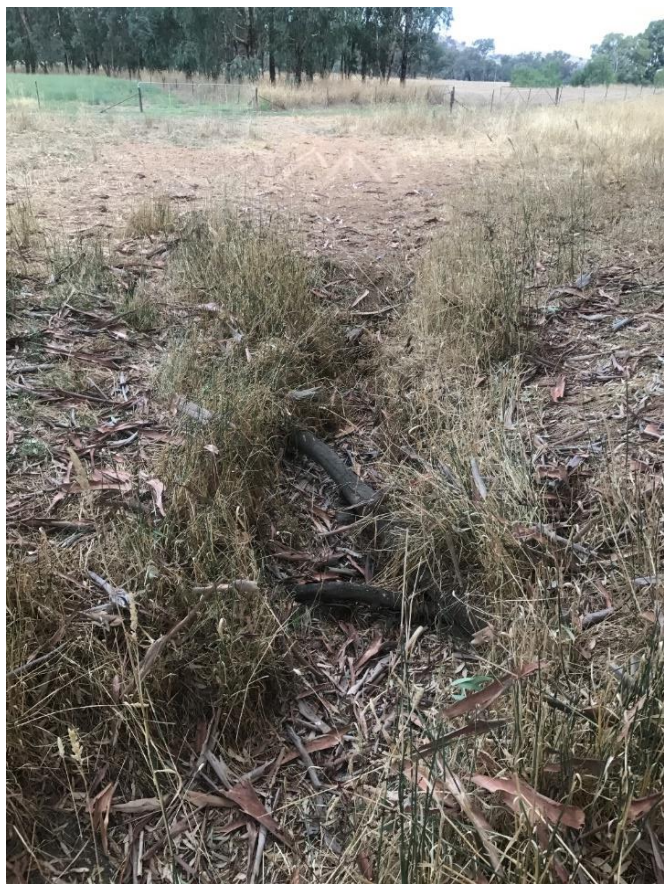
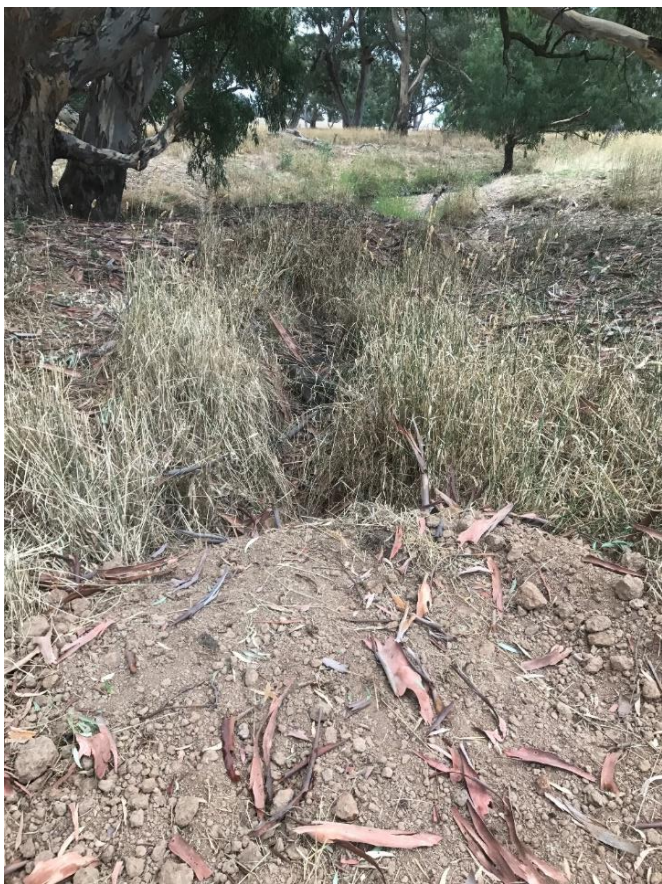
Site 20: Gully formation where tributary enters a creek

A minor gully has formed at this site, where a small tributary enters Kyeamba Creek. The ongoing battering and revegetation of the walls indicates that the rate of retreat is relatively slow at this site, and that existing root structures are doing a good job of maintaining stability, as can be seen in the photos below.

Works would only be recommended if a period of high runoff was to result in a sudden increase in the rate of retreat. As with similar sites, fencing and only periodic grazing would significantly improve the stability of the site. From a hydrological sense, opportunistic and occasional grazing is preferable over set stocking or regular rotations.

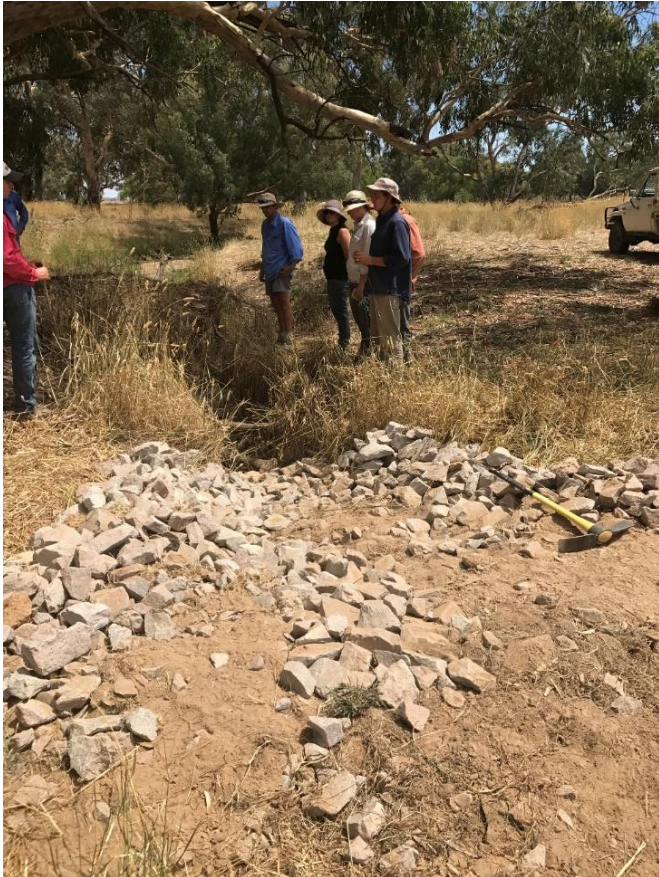
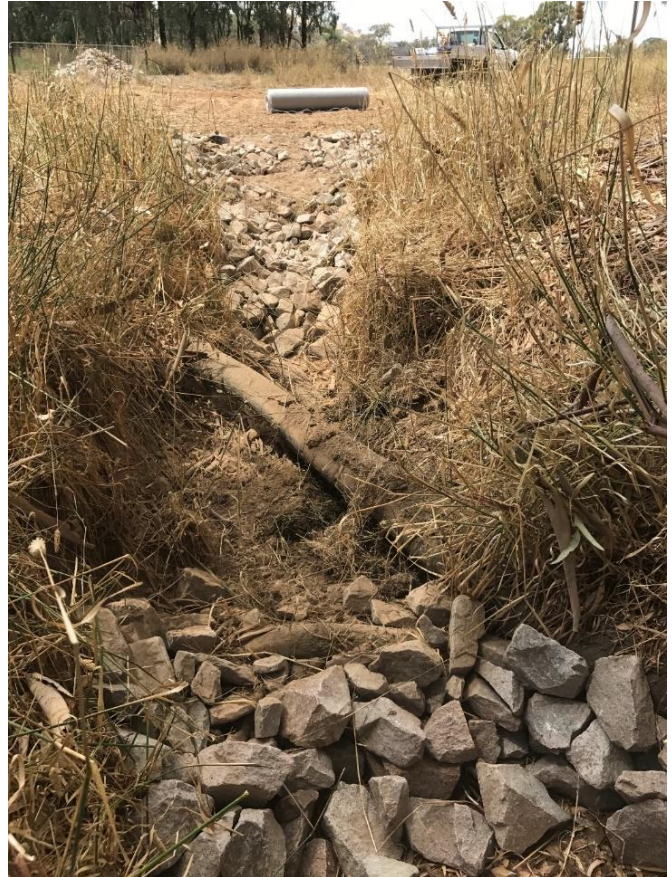
A Rock Rundown was constructed, with the assistance of a number of Landcare members as part of a working bee. As the photos below show, the site has stabilized well.

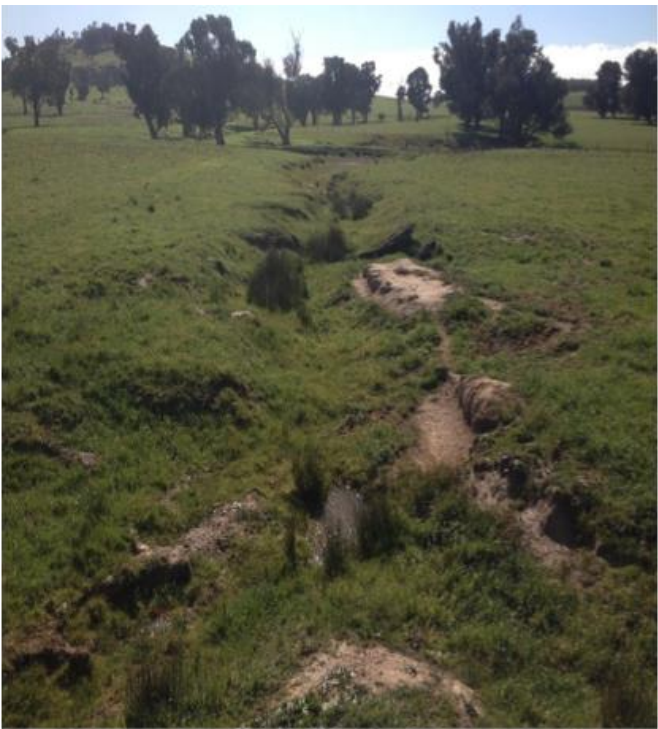
filled with gravel/soil. The image at right shows a schematic of the approximate batter for addressing each of the cuts at this site.

A Rock Rundown is recommended at the head of each of the two active cuts. Armouring the upstream edge of the pool at the confluence is also suggested as this depression could start migrating in either direction in a large flow event.

Based on the catchment area, 200 mm rock is recommended if it is well keyed and in-

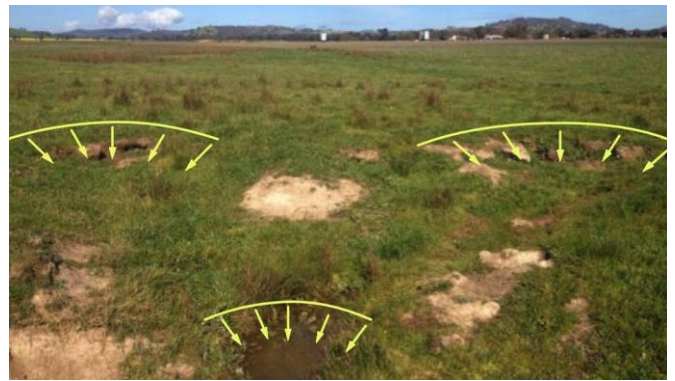
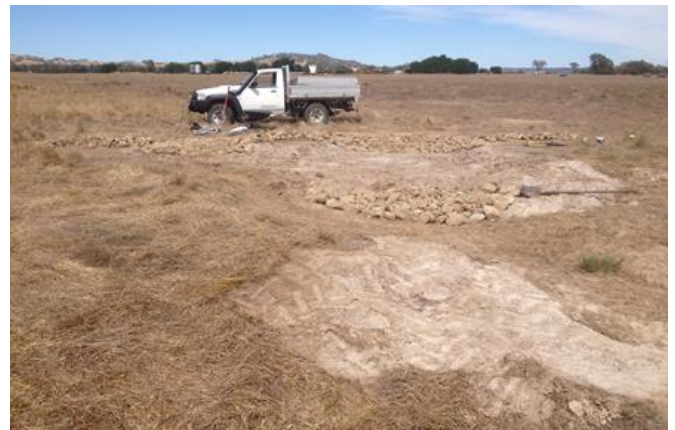
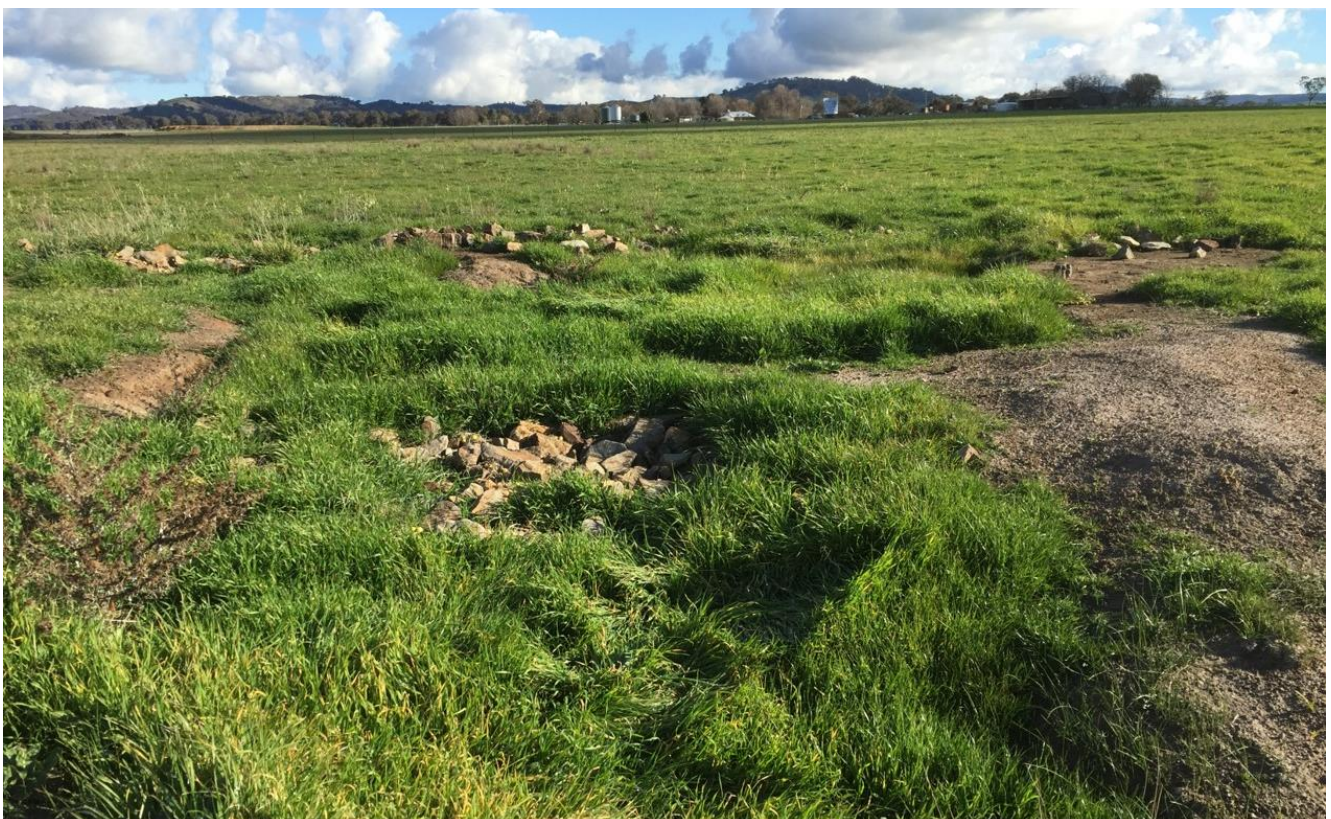
The landholders shaped the edges of the headcuts, covered the sodic soil with a layer of topsoil and covered this with geofabric. A series of Rock Rundowns were then constructed, as can be seen in the photo at right, using rock of 200 - 400 mm diameter. Gypsum was scattered over the top, as was seed of sedge and prickly tea tree. The site has performed well in the rainfall received since these works were completed, as can be seen in the photo below. The landholders have found the area to be very stable, with water trickling slowly through the structure, depositing sediment and allowing grasses and shrubs to germinate and establish well. The paddock has now been stocked on and off, with no impact on works.
